Appendix A

19 Spring Street

PID 25031626

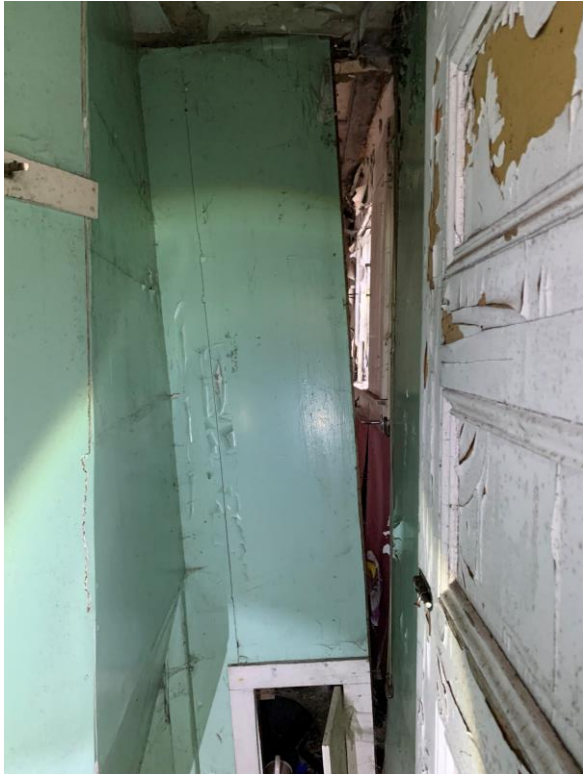
Interior walls separating from exterior walls.

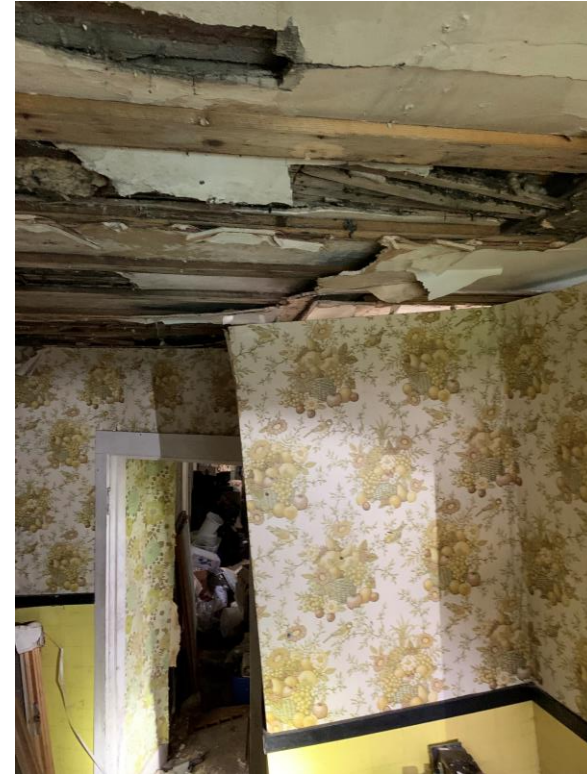
Interior Walls separating from exterior walls.

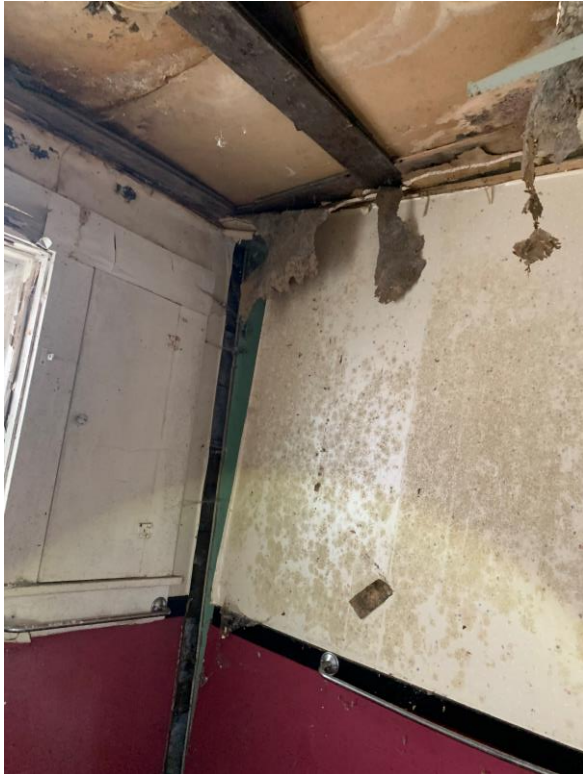
Main floor bathroom. Interior walls separating from exterior walls.

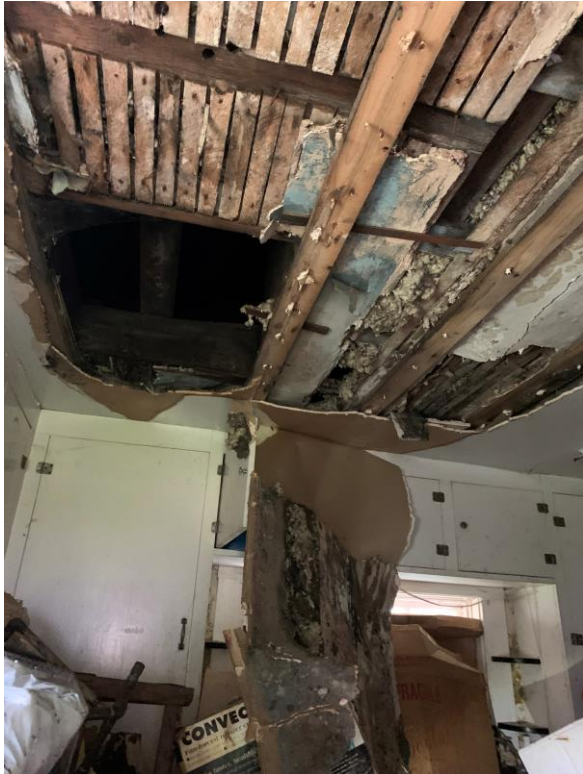
Significant water damage to main floor kitchen.

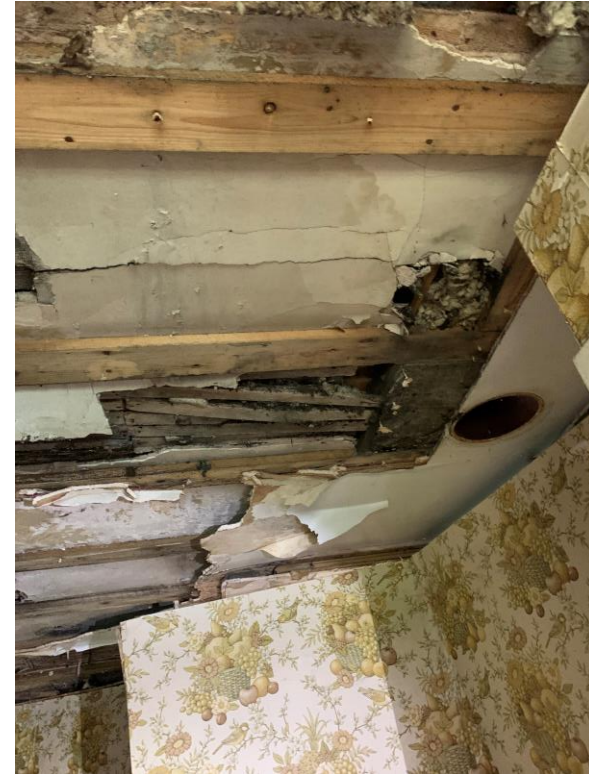
Significant water damage to main floor kitchen.

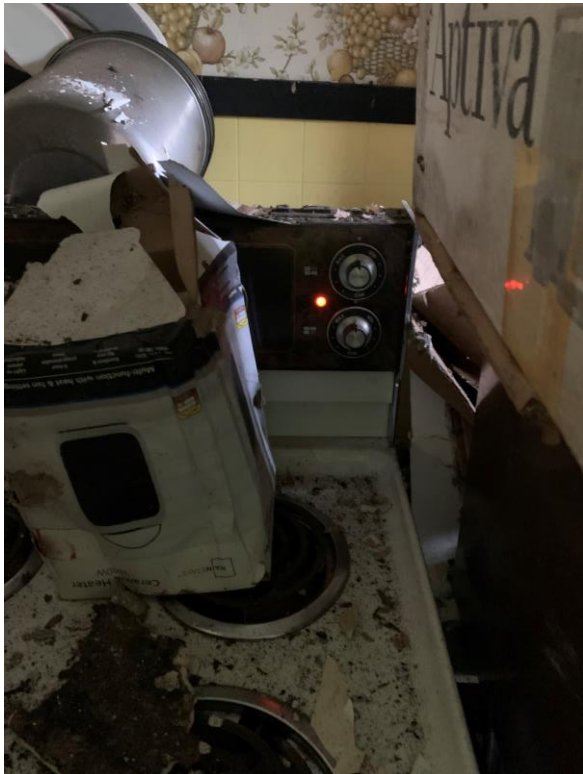
Oven was on, element appeared to be burnt out.

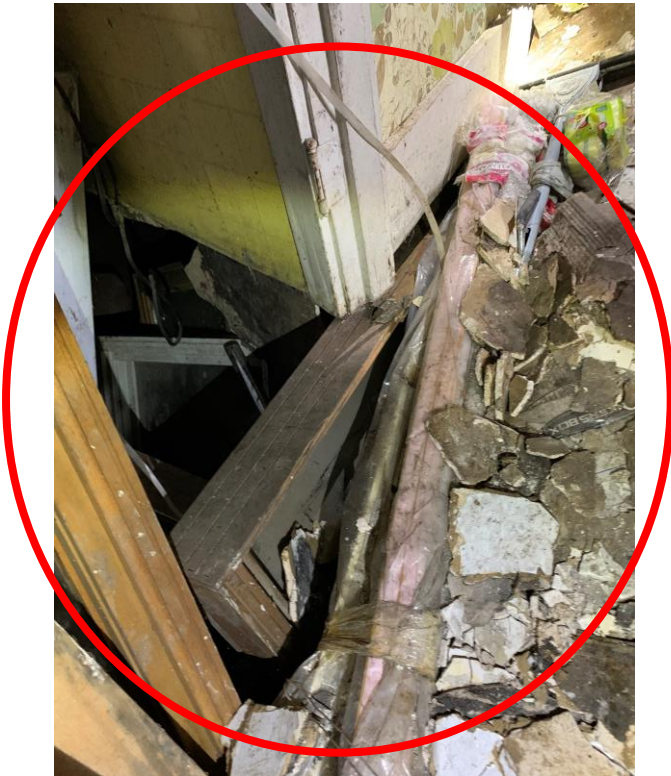
Floor has completely collapsed into basement. Hallway door frame is resting on debris.

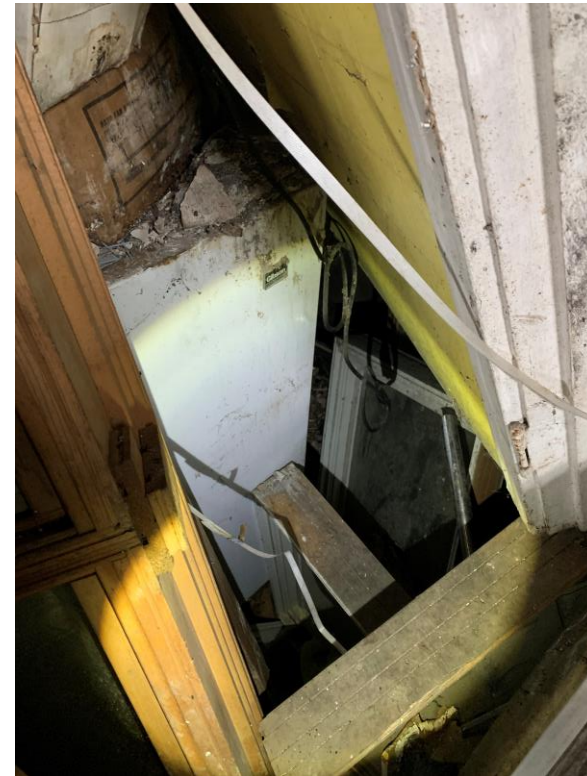
Refrigerator has fallen into the basement due to the collapsed floor.

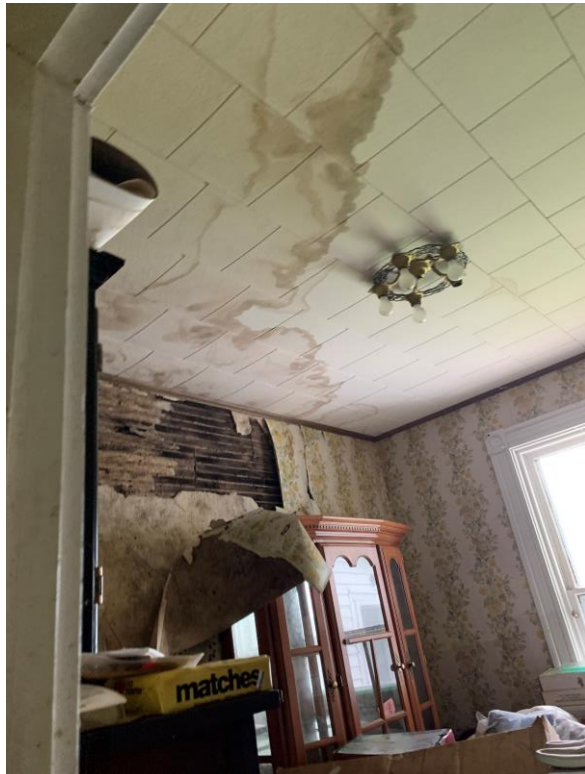
Main floor water damage.

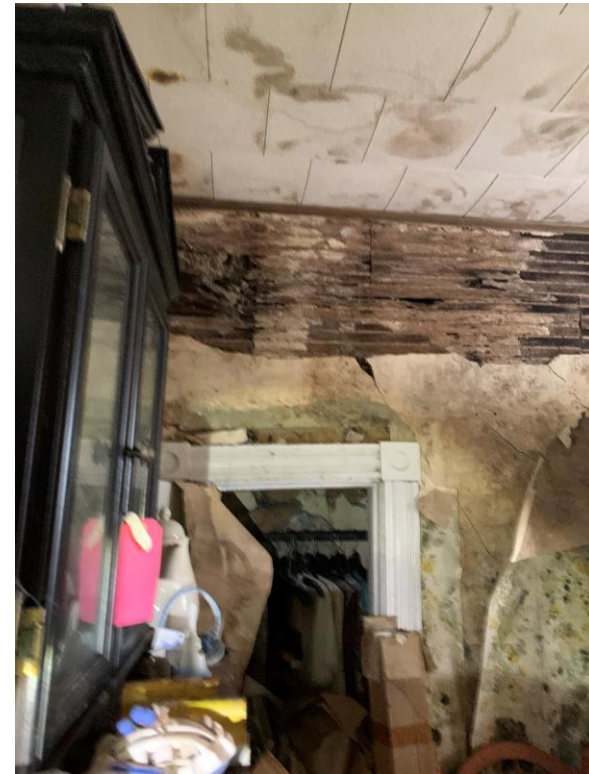
Main floor water damage.

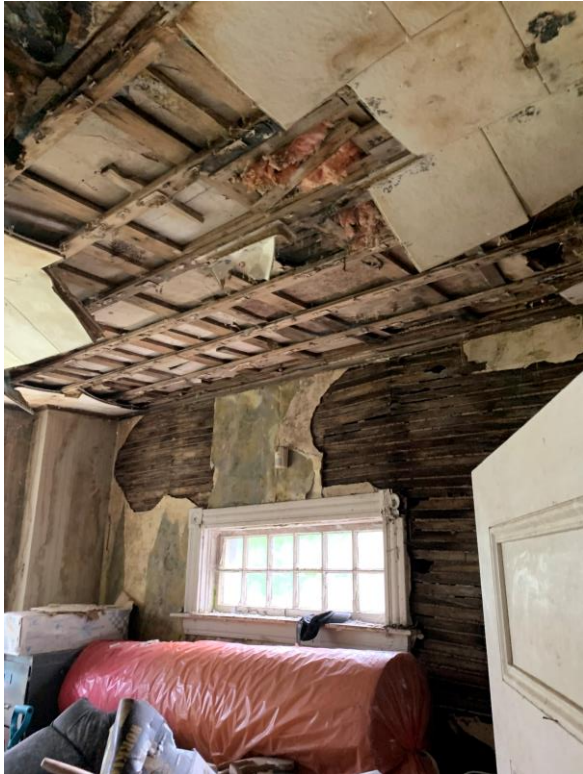
Main floor water damage.

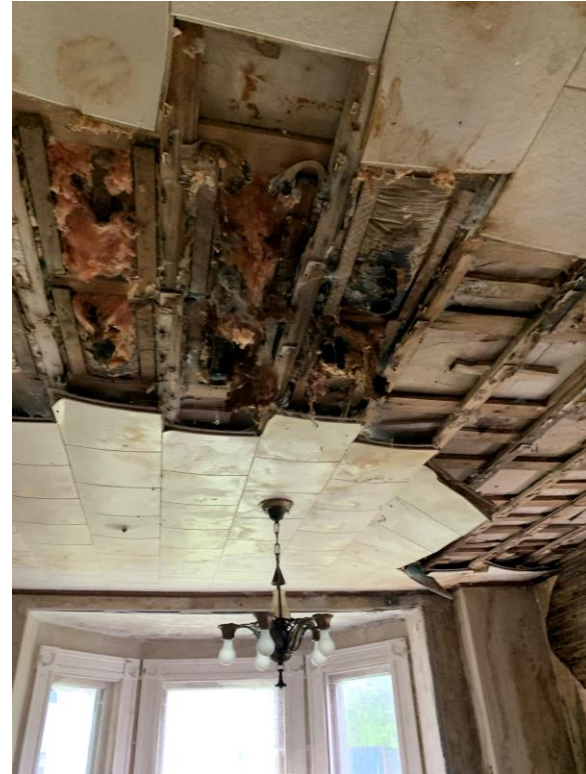
Main floor water damage.

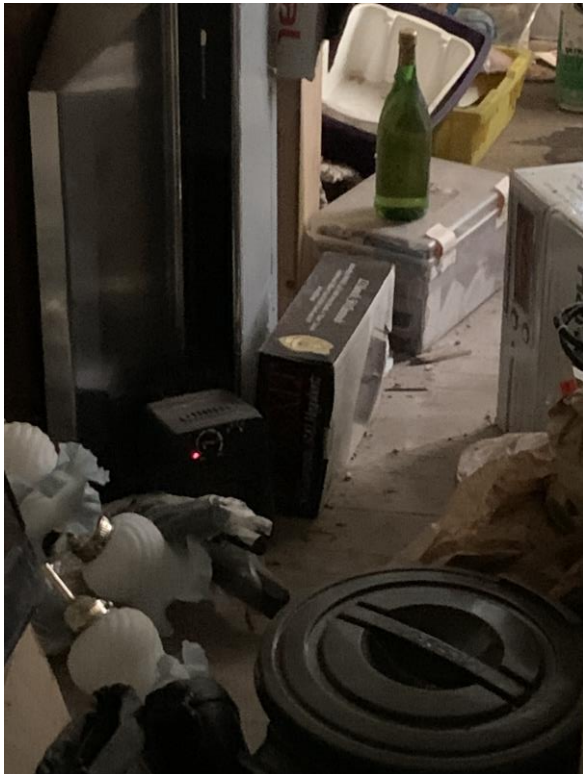
Space heater on and running.

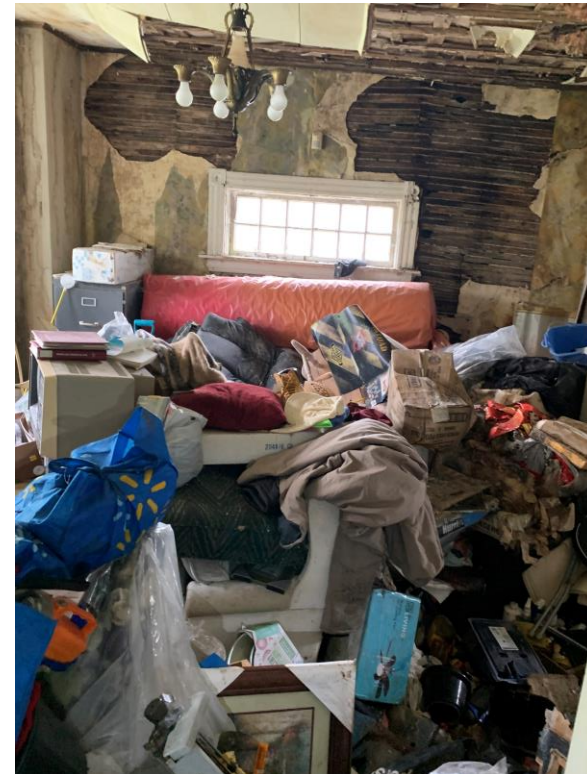
Main floor water damage, hoarding.

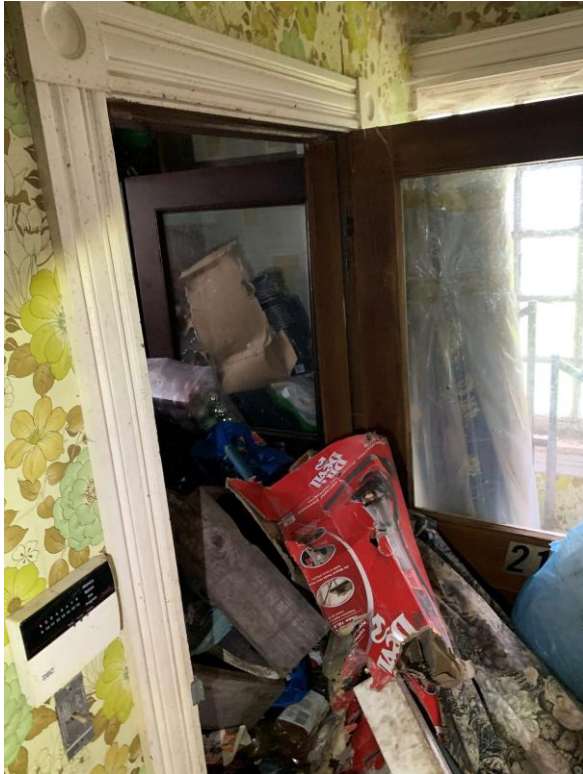
Main floor hoarding.

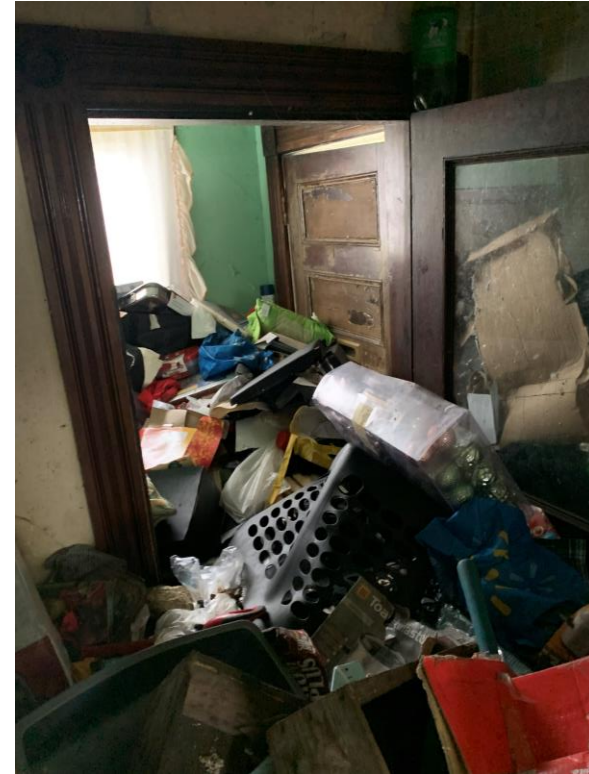
Main floor hoarding.

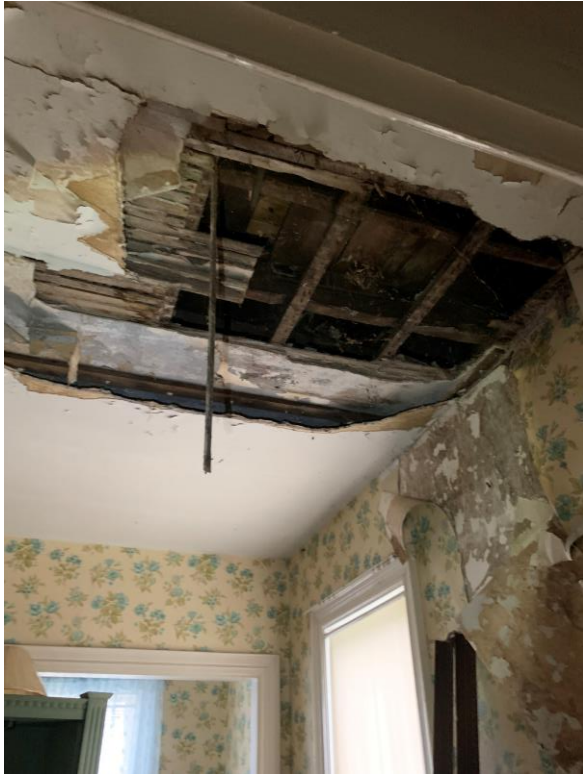
Second-floor water damage.

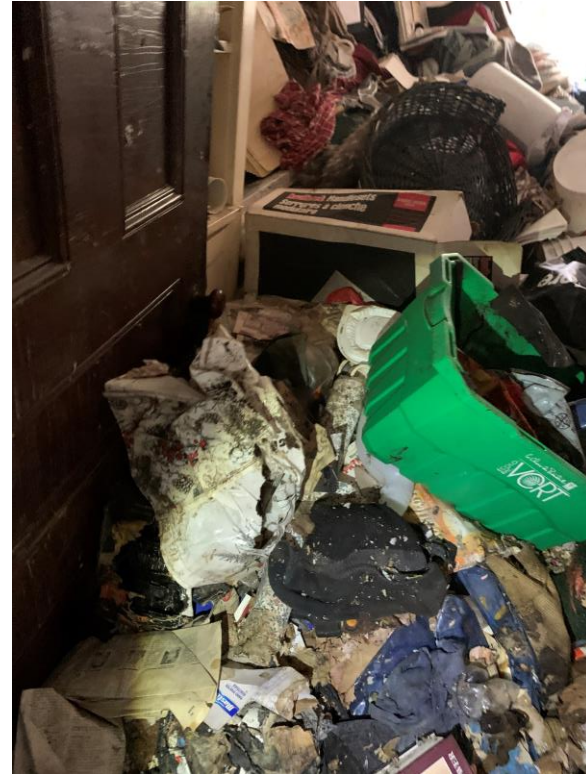
Second-floor hoarding/garbage.

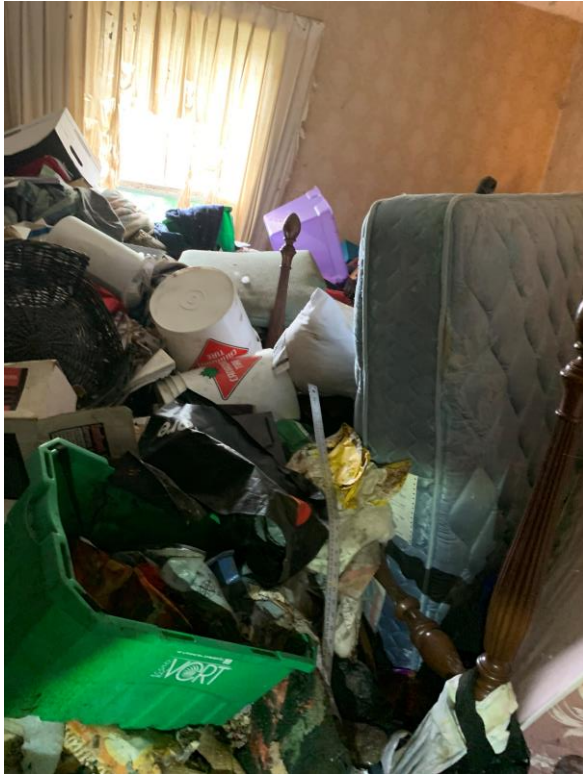
Second-floor hoarding/garbage.

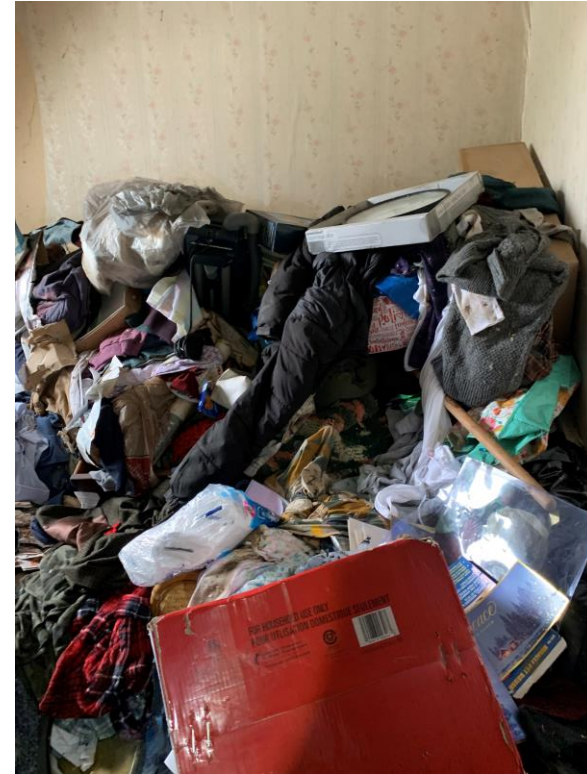
Second-floor hoarding/garbage.

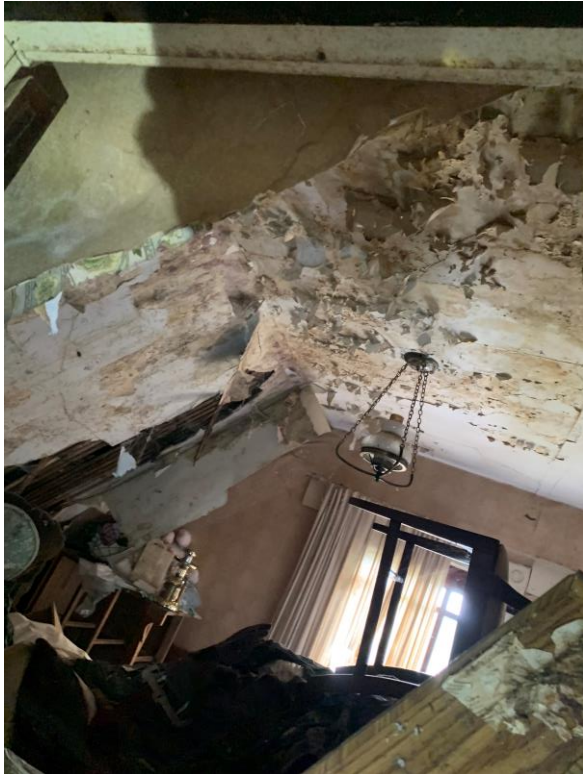
Second-floor water damage.

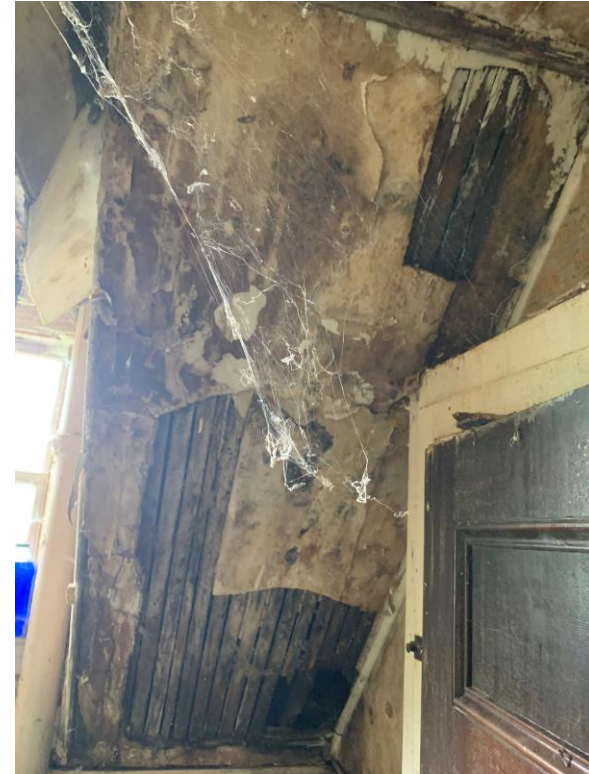
Second-floor water damage.

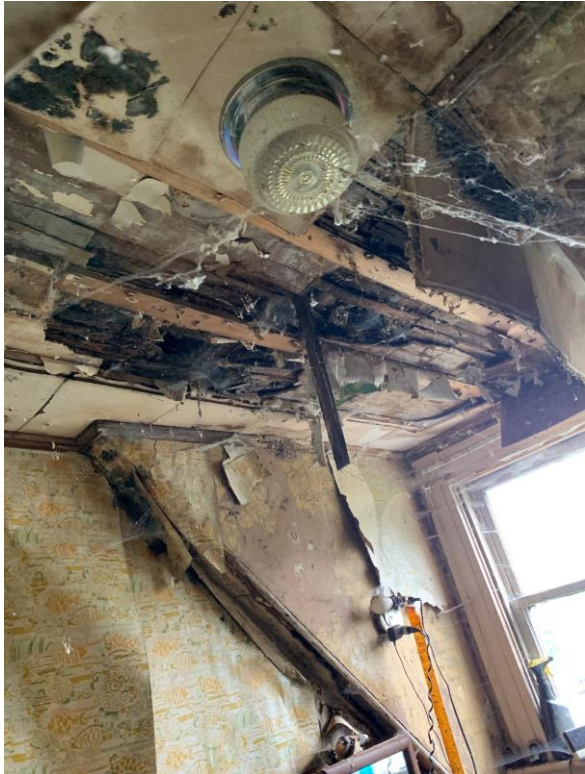
Second-floor bathroom water damage.

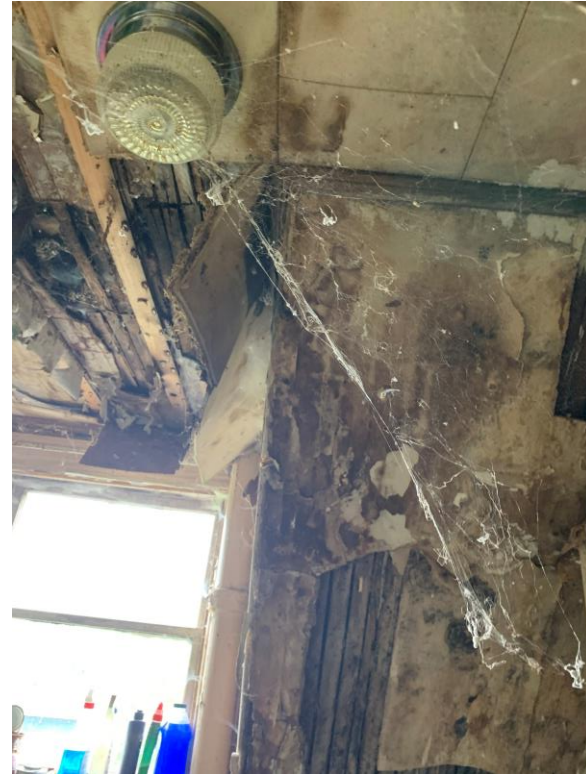
Second-floor bathroom water damage.

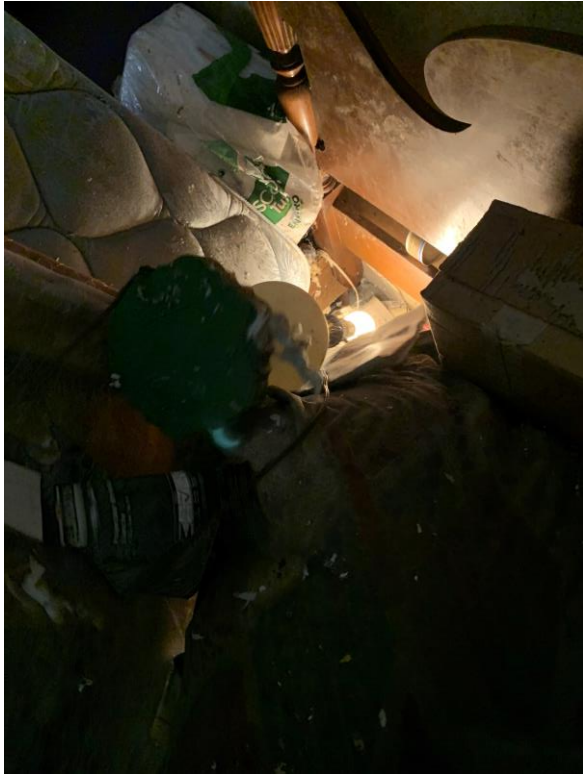
Second-floor bedroom. Light fallen onto mattress and papers.

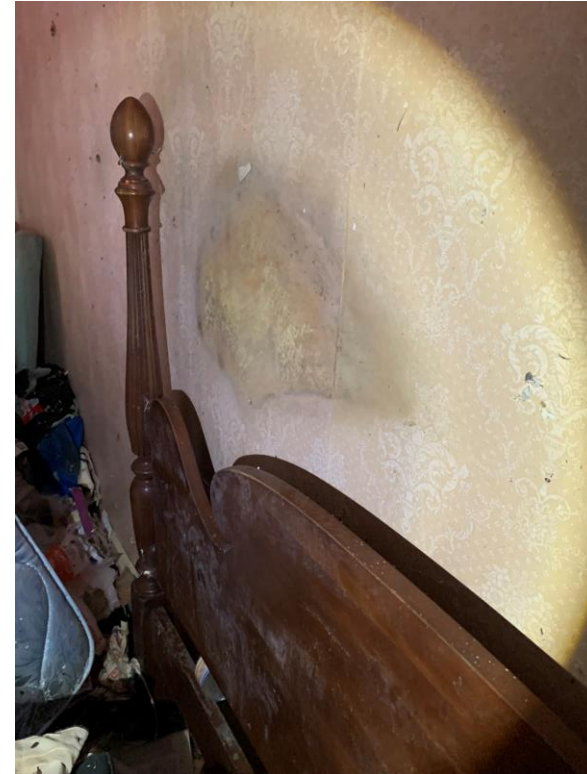
Second-floor bedroom. Light appeared to scorched wallpaper.

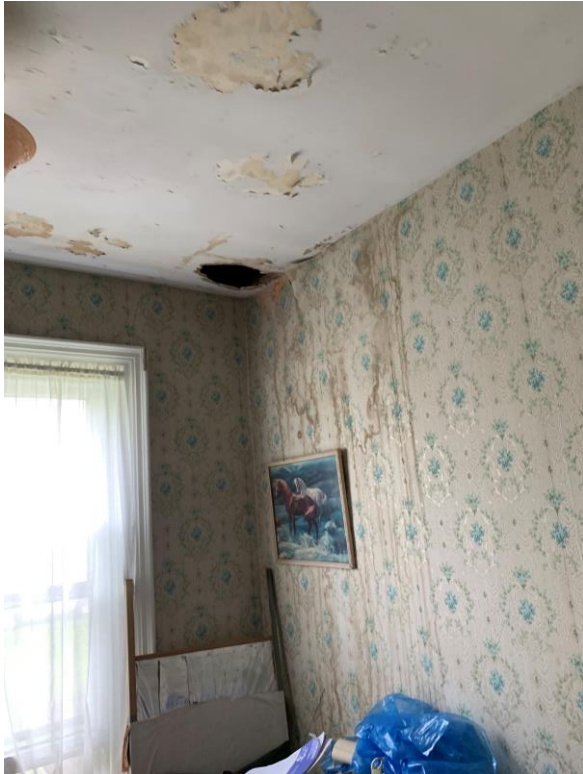
Water damage on second-floor.

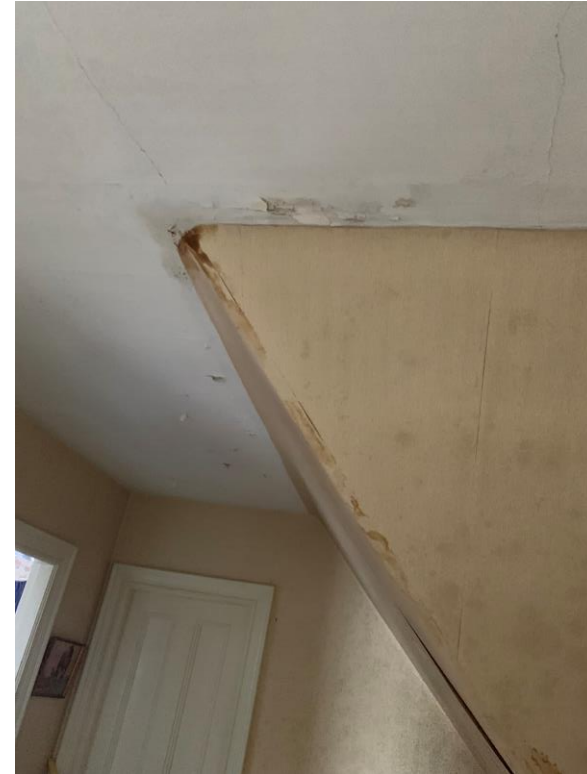
Minor water damage on second-floor.

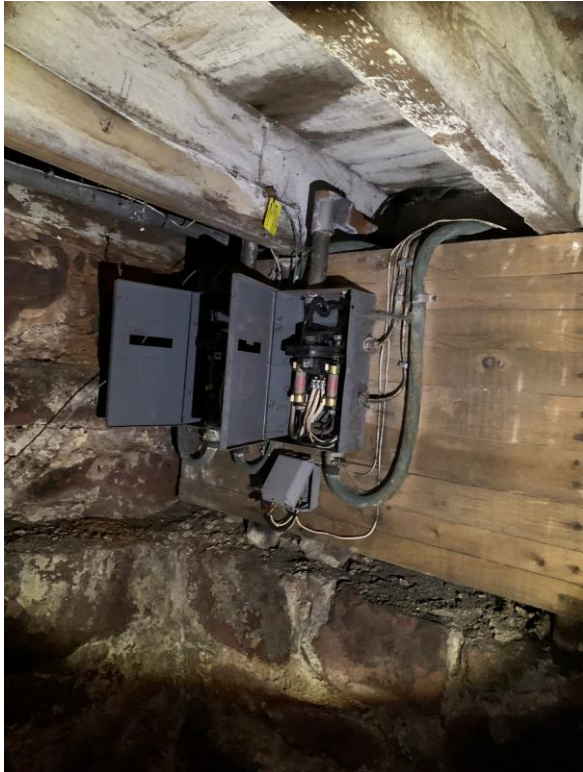
Electrical and furnace is accessible through occupied unit.

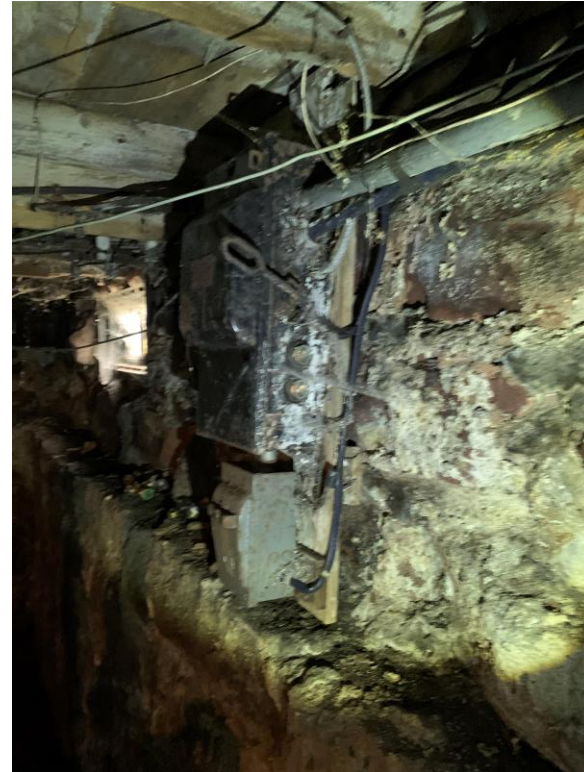
Basement: Main gear box in extremely poor condition. Accessible through occupied unit

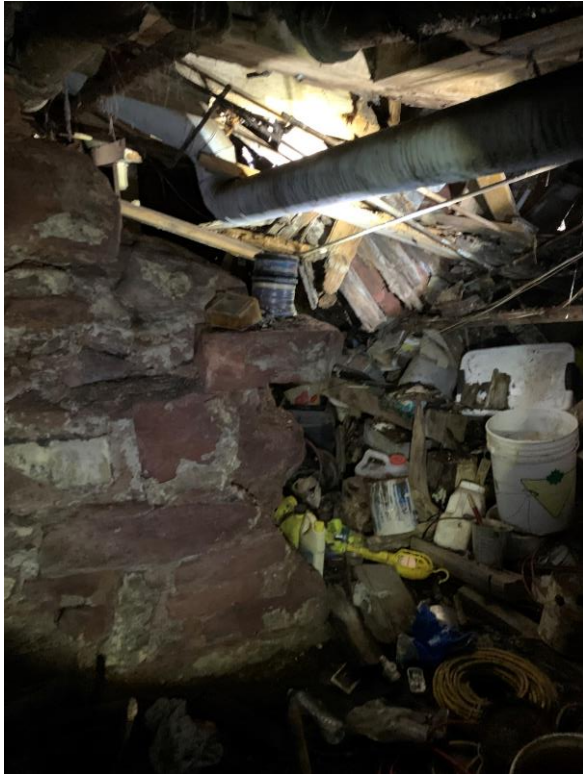
Basement. Collapse of unoccupied unit.
