Building Assessment

TN Trenholm Construction Inc.

As requested, I have conducted an initial walkthrough of the building located at **19 Spring Street, Amherst N.S., B4H 1R6** to assess what would be required to bring the structure up to livable standards, including addressing code violations.

Date of Assessment: **September 18, 2024**

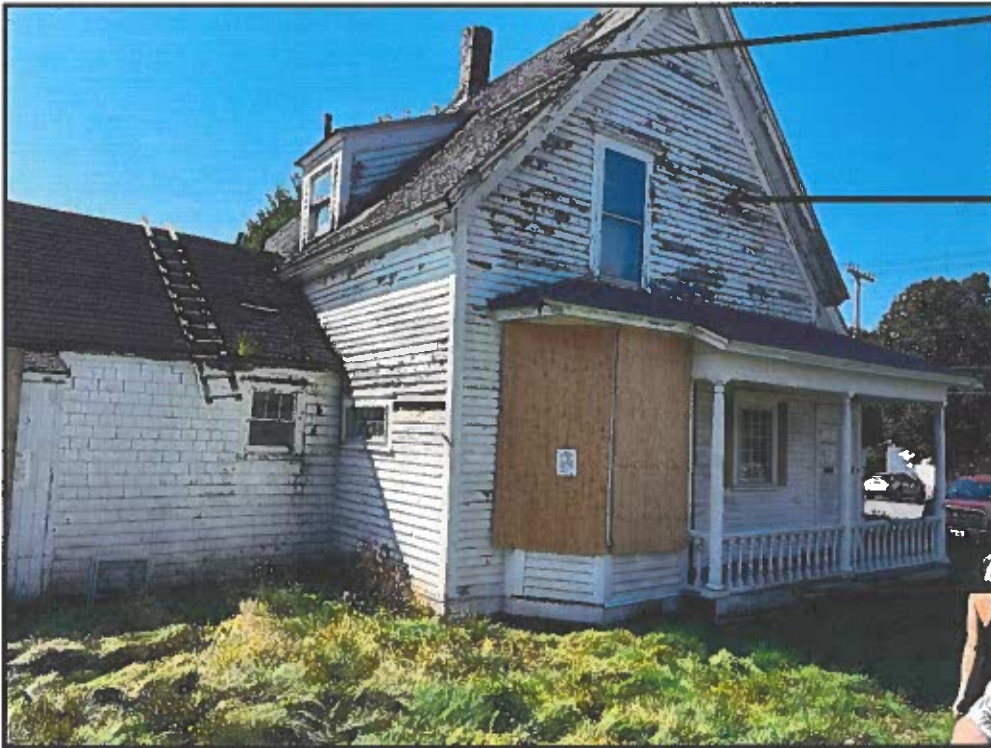
Damaged & missing roof shingles

Damaged and missing siding

Rotting members at entryways

Necessary replacement of all doors and windows to meet code standards

Roof and walls are bowed with many broken structural elements indicating that the building is experiencing significant and active structural failure

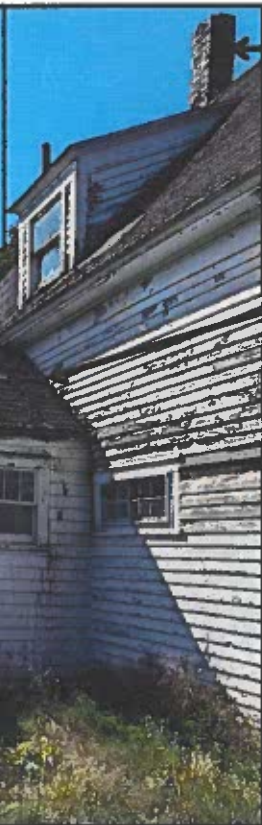
Deteriorating chimney

Damaged roof shingles

Damaged and missing siding

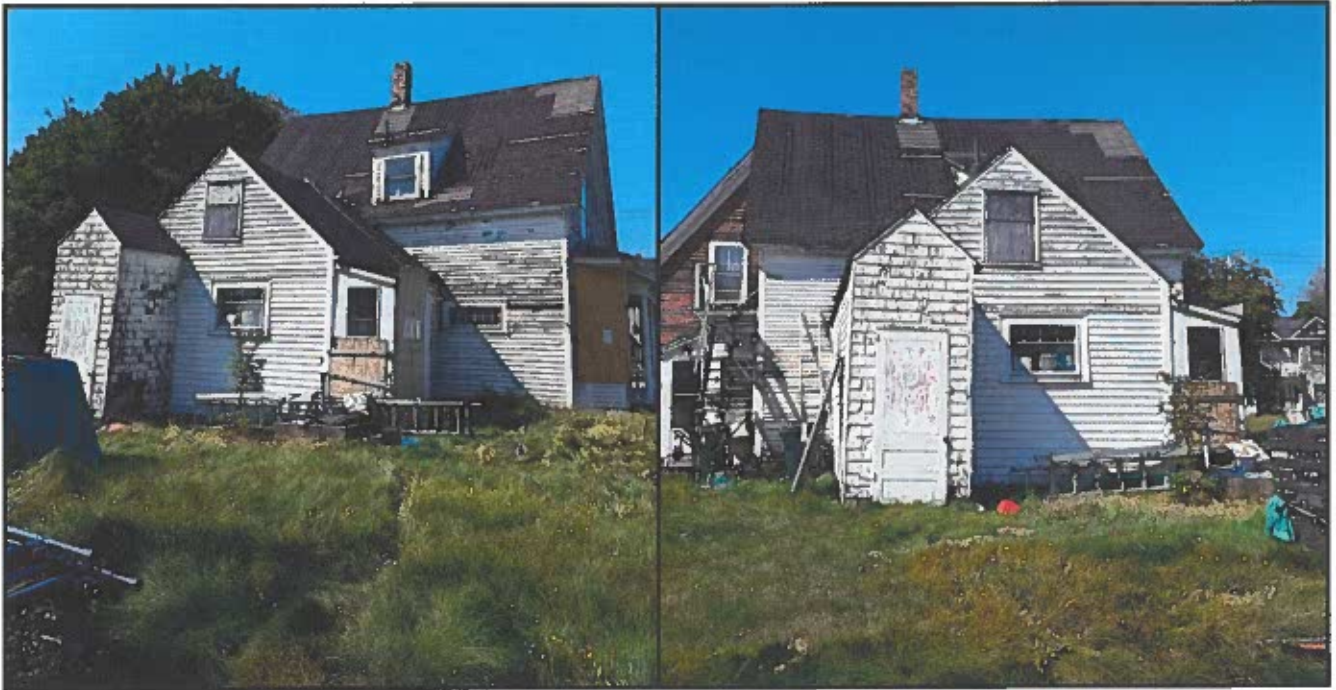
**Damaged eaves
and soffits**

**Damaged and
missing siding**

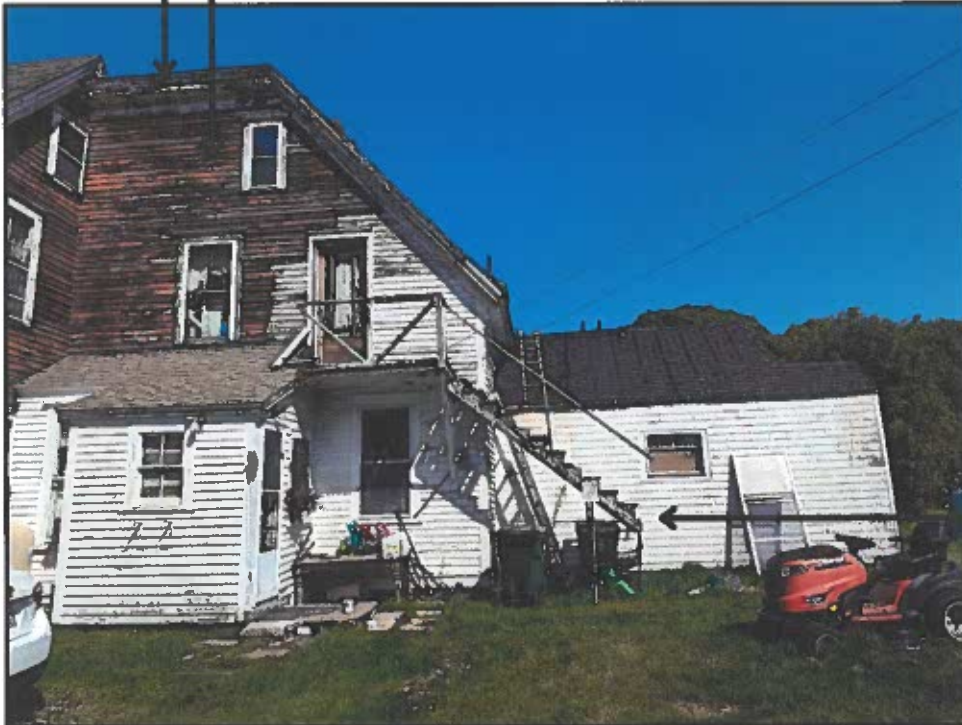
**Extensive
deterioration of
the second-floor
deck and stairs**

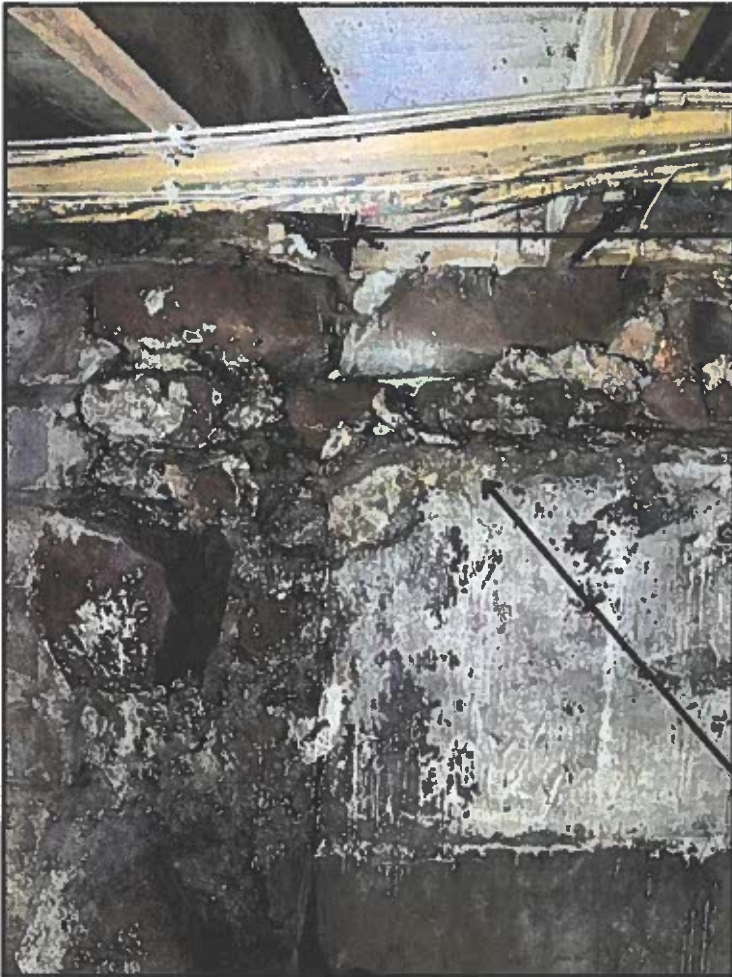
Outdated knob and tube wiring

Significant amount of holes & loose rocks throughout foundation

Broken open window, rotten beyond repair

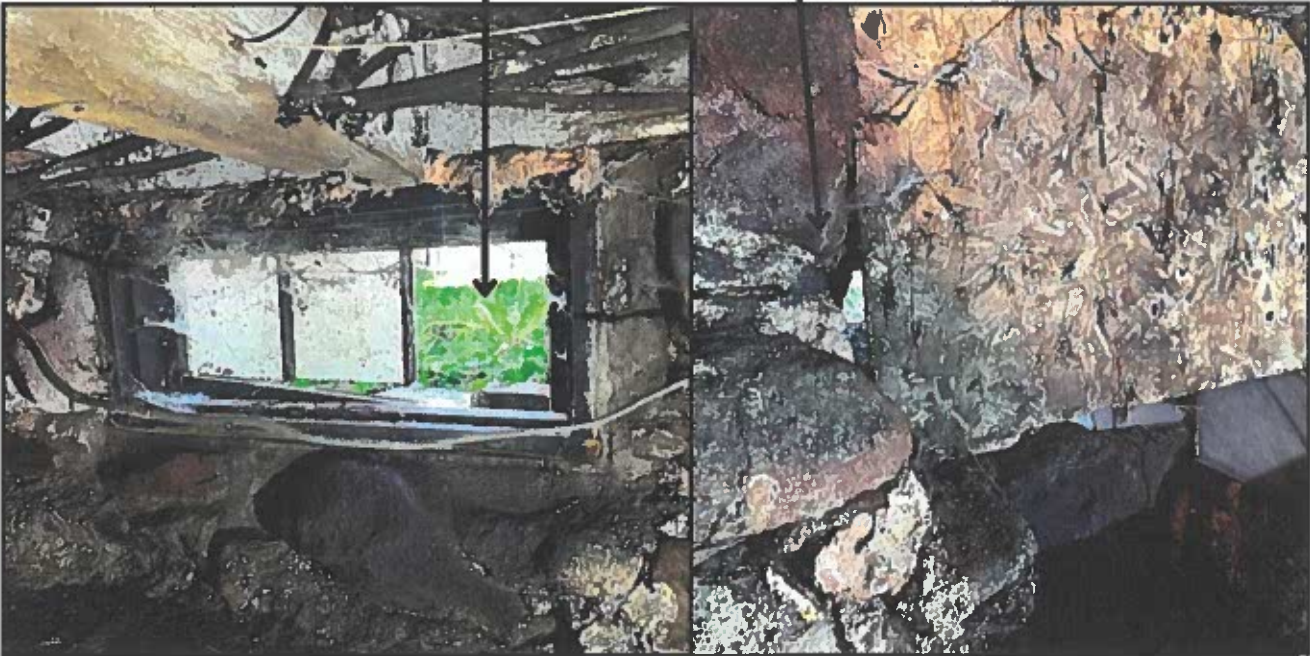
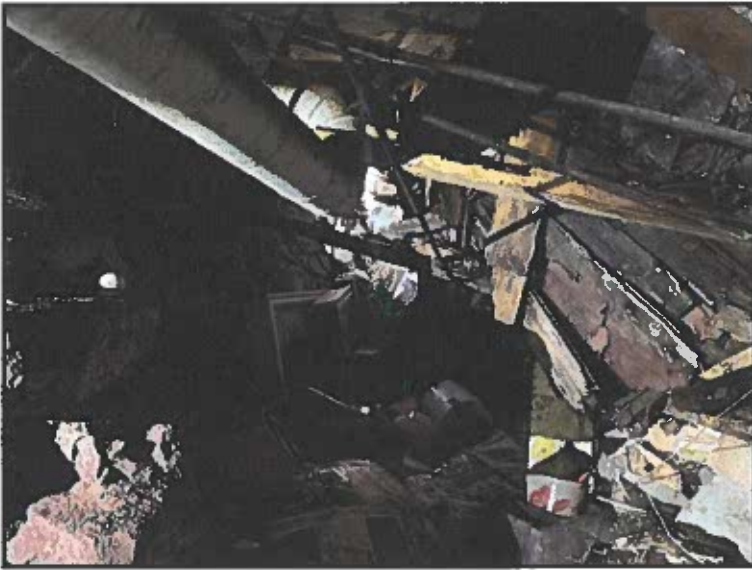
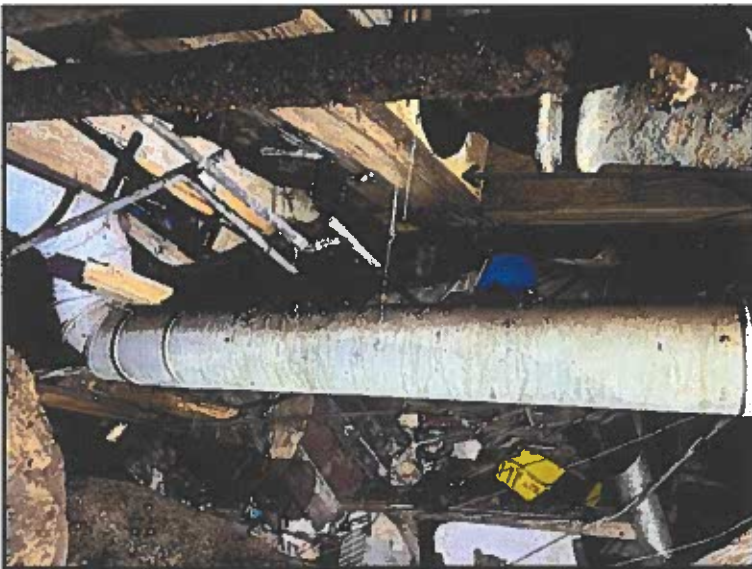
All three images show large section of floor above has collapsed into basement causing significant structural damage, damage to mechanical and electrical services and leaves structure above highly unstable.

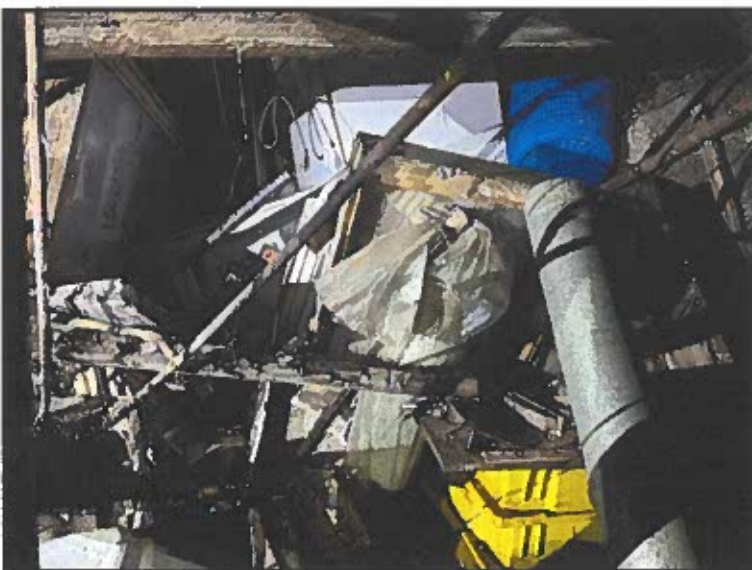
10"x10" Main support beam broken and rotten

Significant amount of personal belongings and debris, some of which appear to be supporting collapsed floor and structural elements. Removal of this material may trigger further structural instability and potential collapse of the surrounding areas.

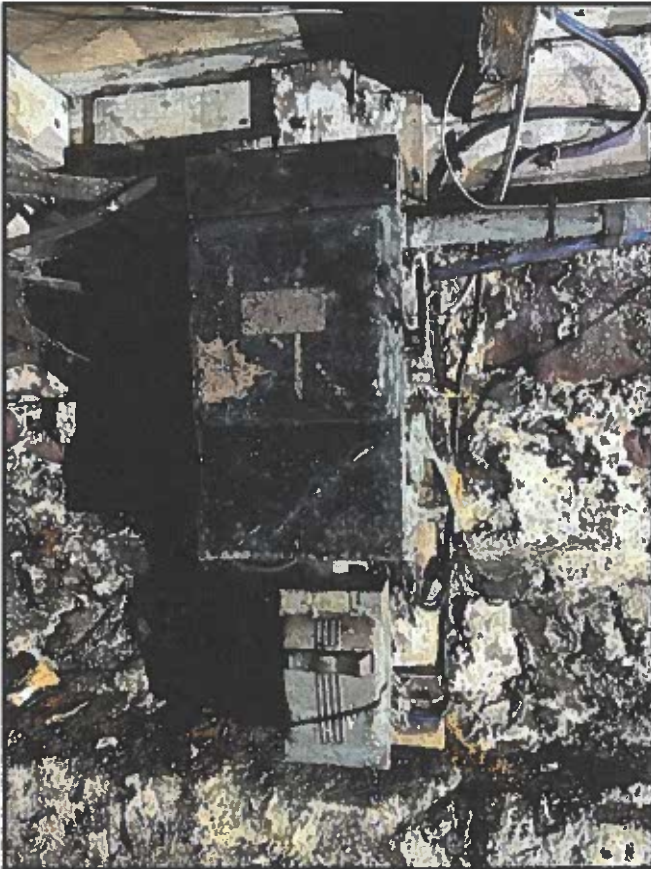
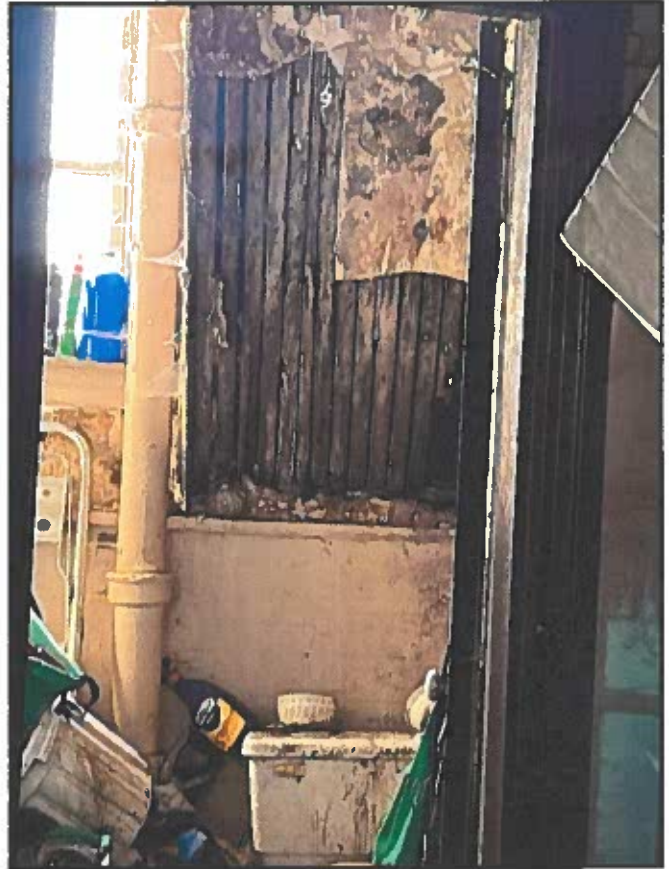
Outdated main power entrance, all electrical needs to be replaced to meet current code standards.

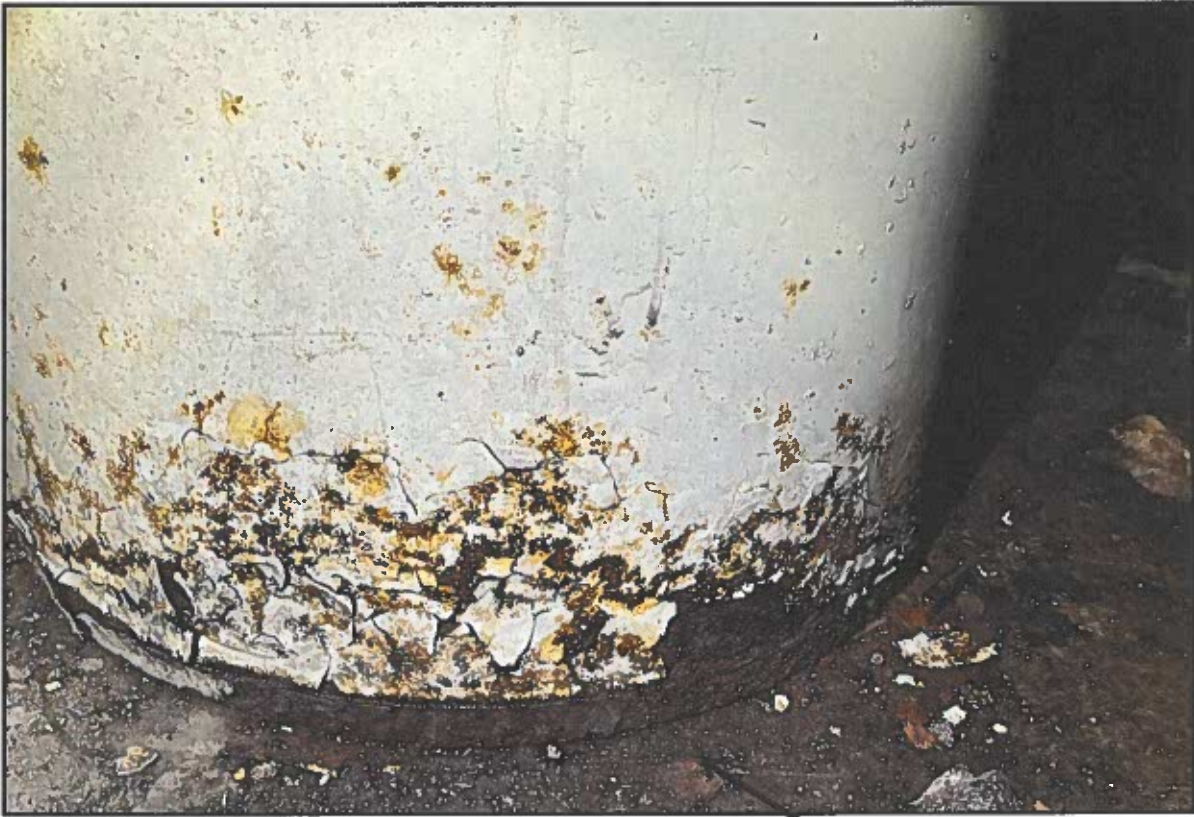
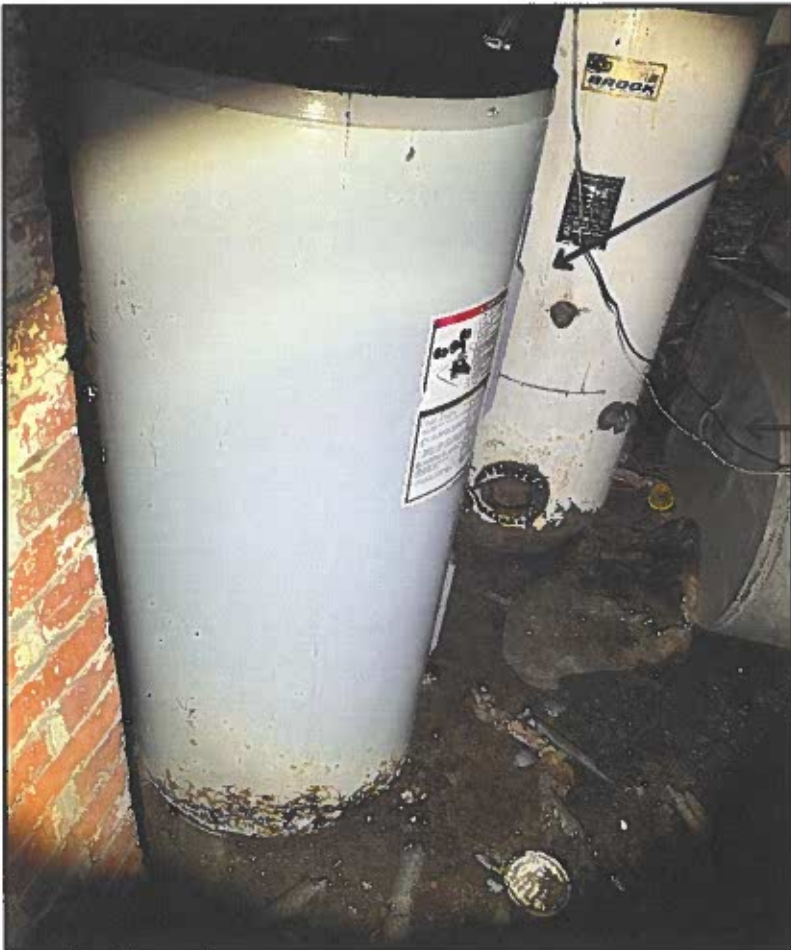
Failed plumbing and plumbing fixtures. All plumbing needs to be replaced to meet current code standards.

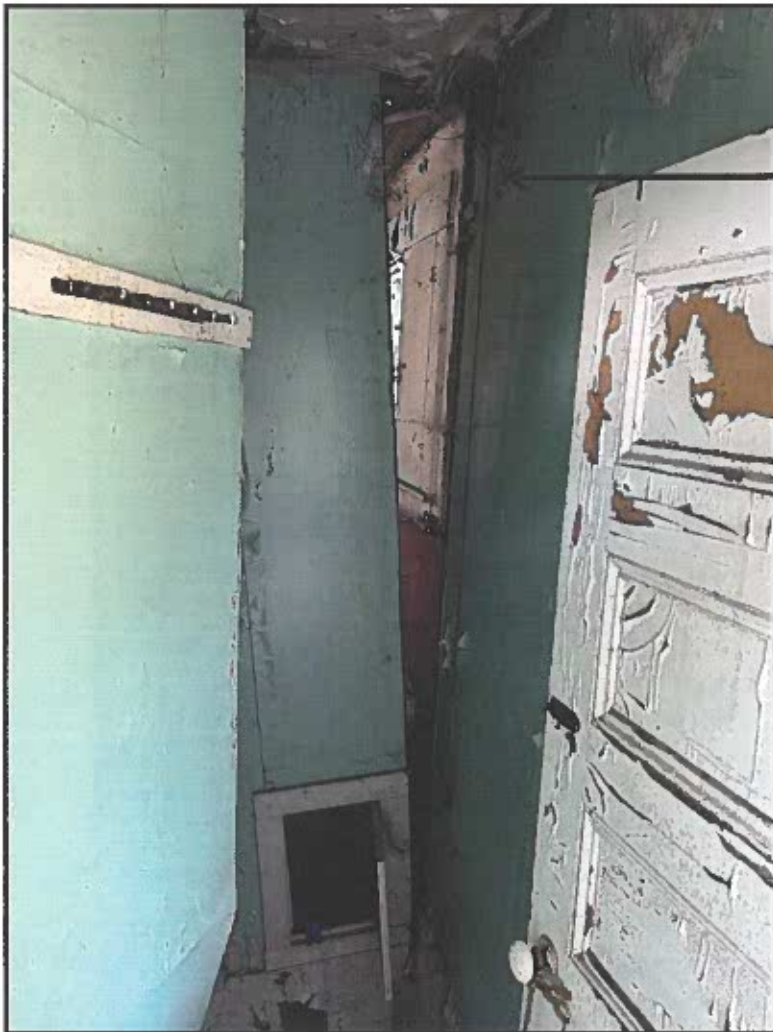
Slanted door frame due to active settlement. Approximately 3 1/2" of settlement in a 3'-0" run

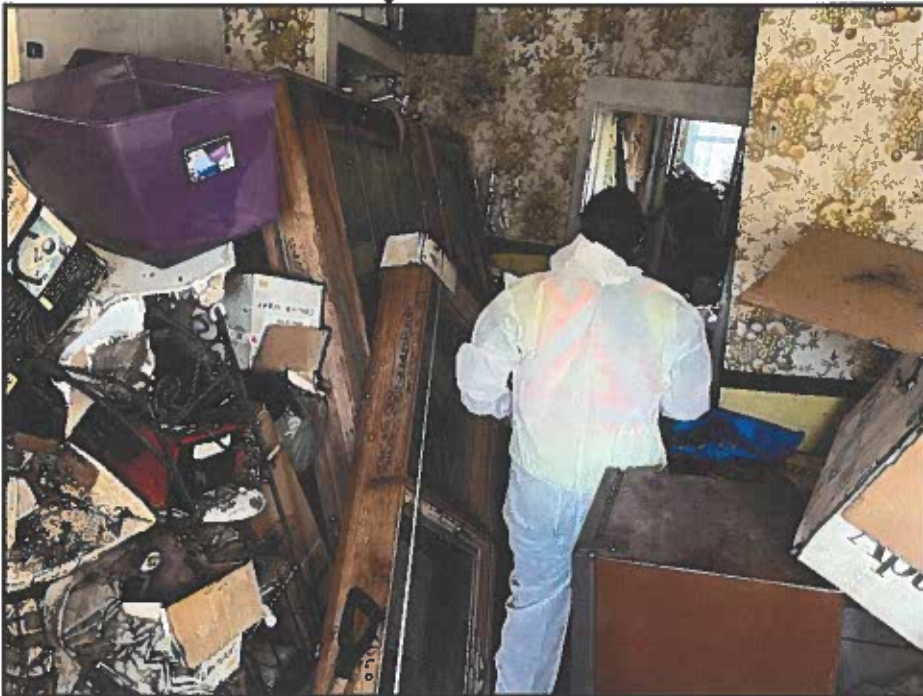
Wall actively pulling away from adjacent wall due to extreme settlement

Slanted door frame due to active settlement

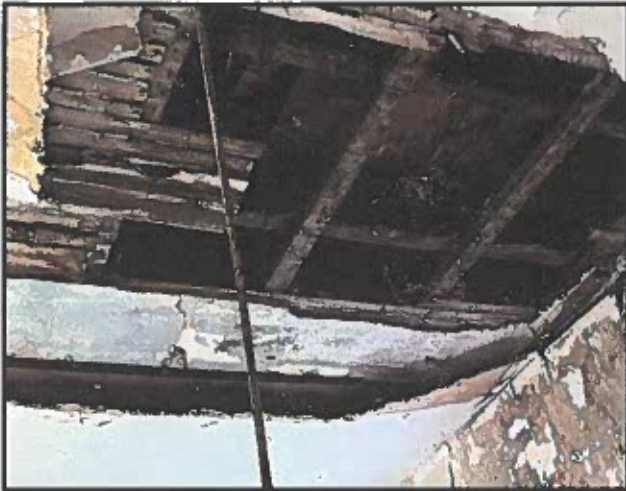
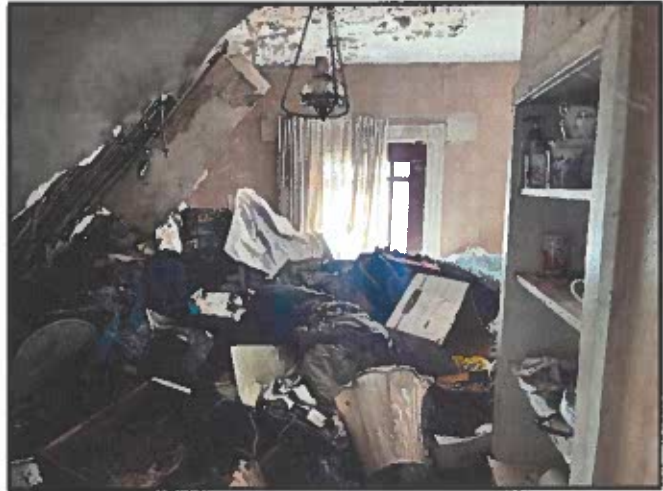
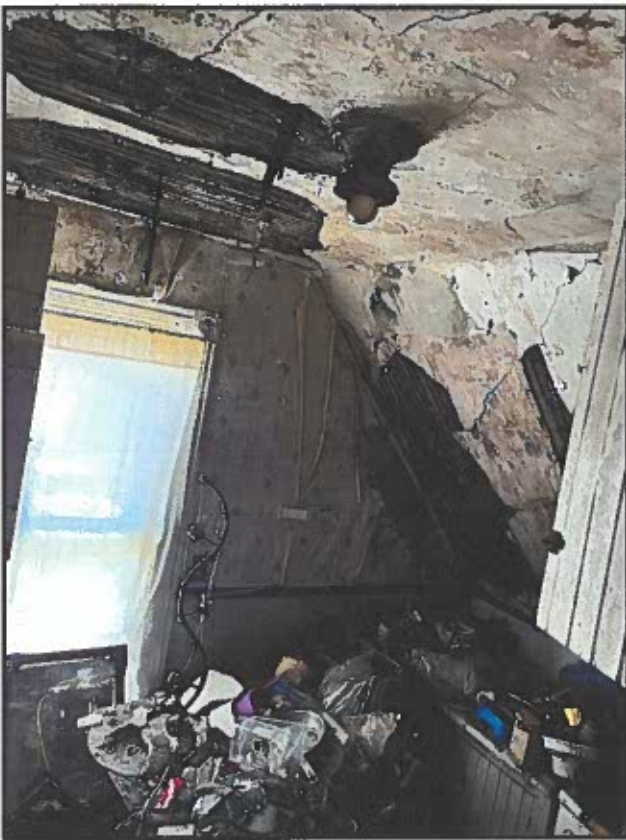
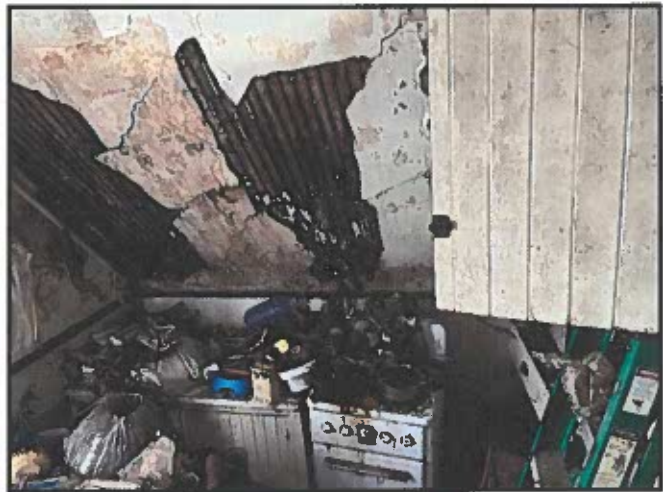
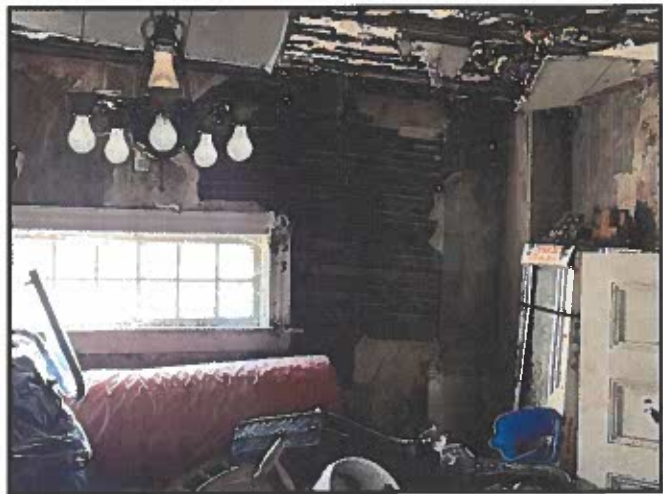
Years of unaddressed water damage in walls and ceilings

Numerous cracks in walls due to settlement

mold

All images show extensive damage to interior finishes due to prolonged water damage, structural settlement, prolonged mold issues and the build up of personal belongings and debris causing multiple bio hazards. All interior walls, ceilings, floors, moldings, finishes, etc. will need to be replaced.

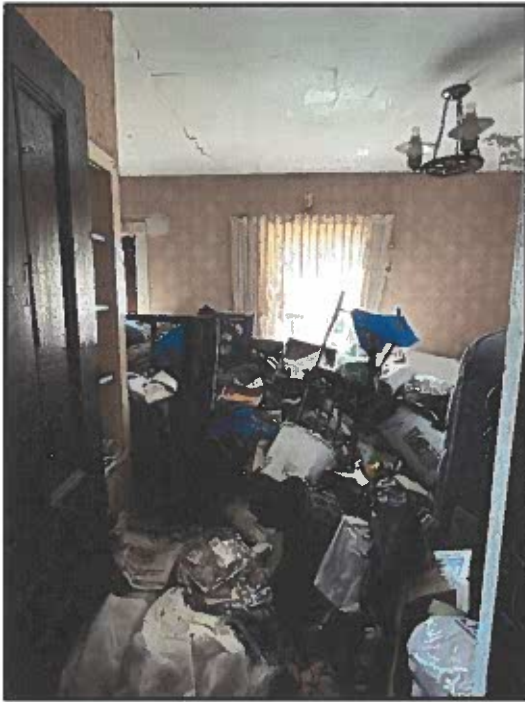
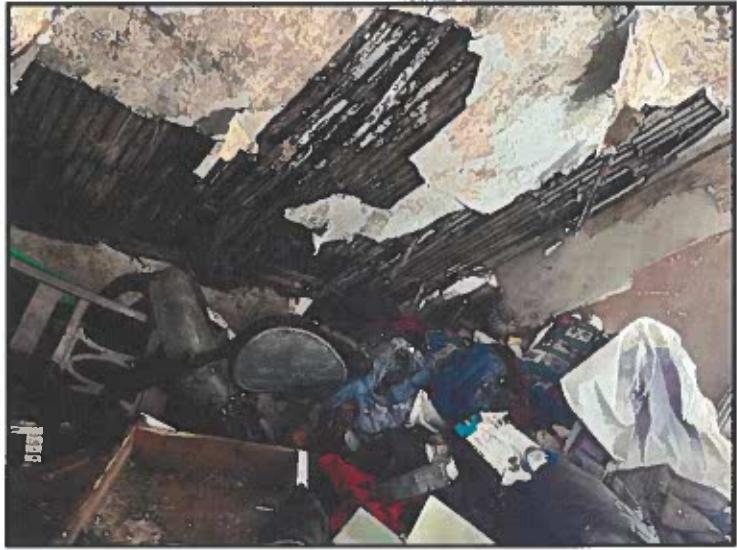
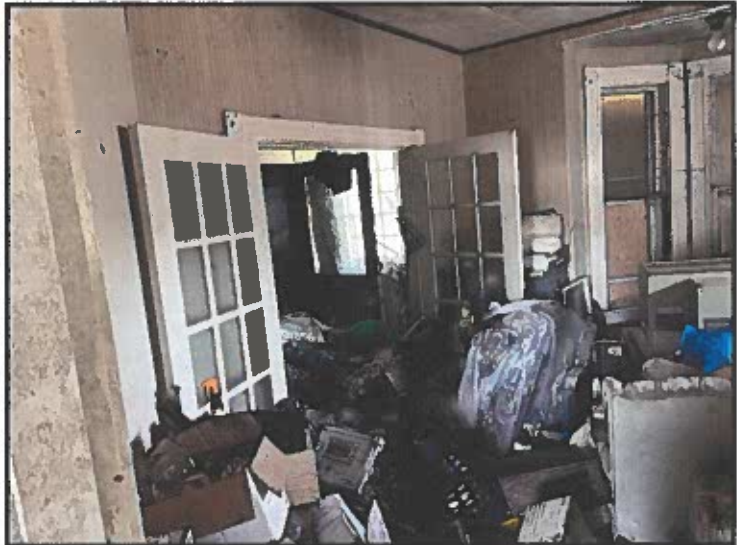
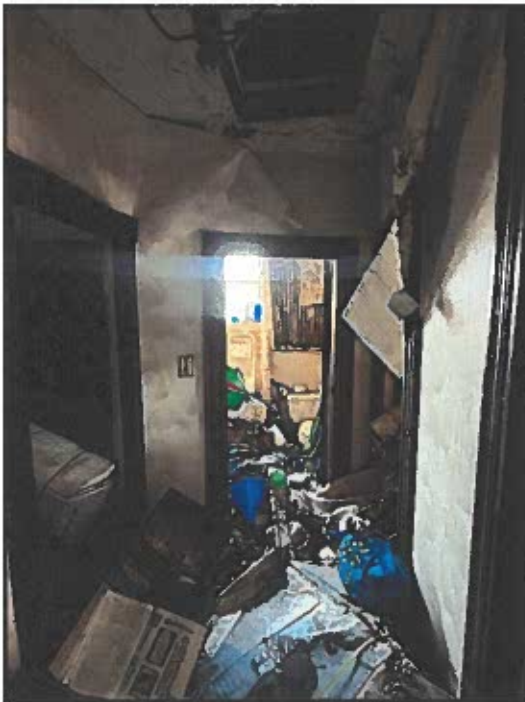
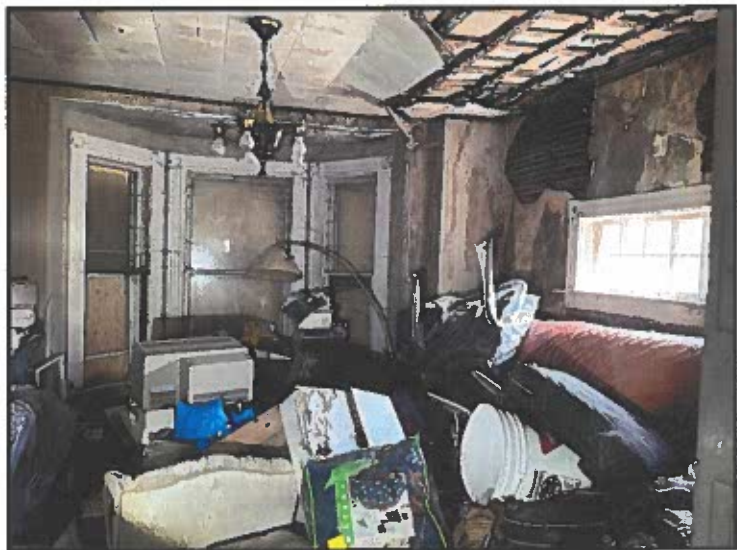
All images show extensive damage to interior finishes due to prolonged water damage, structural settlement, prolonged mold issues and the build up of personal belongings and debris causing multiple bio hazards. All interior walls, ceilings, floors, moldings, finishes, etc. will need to be replaced.

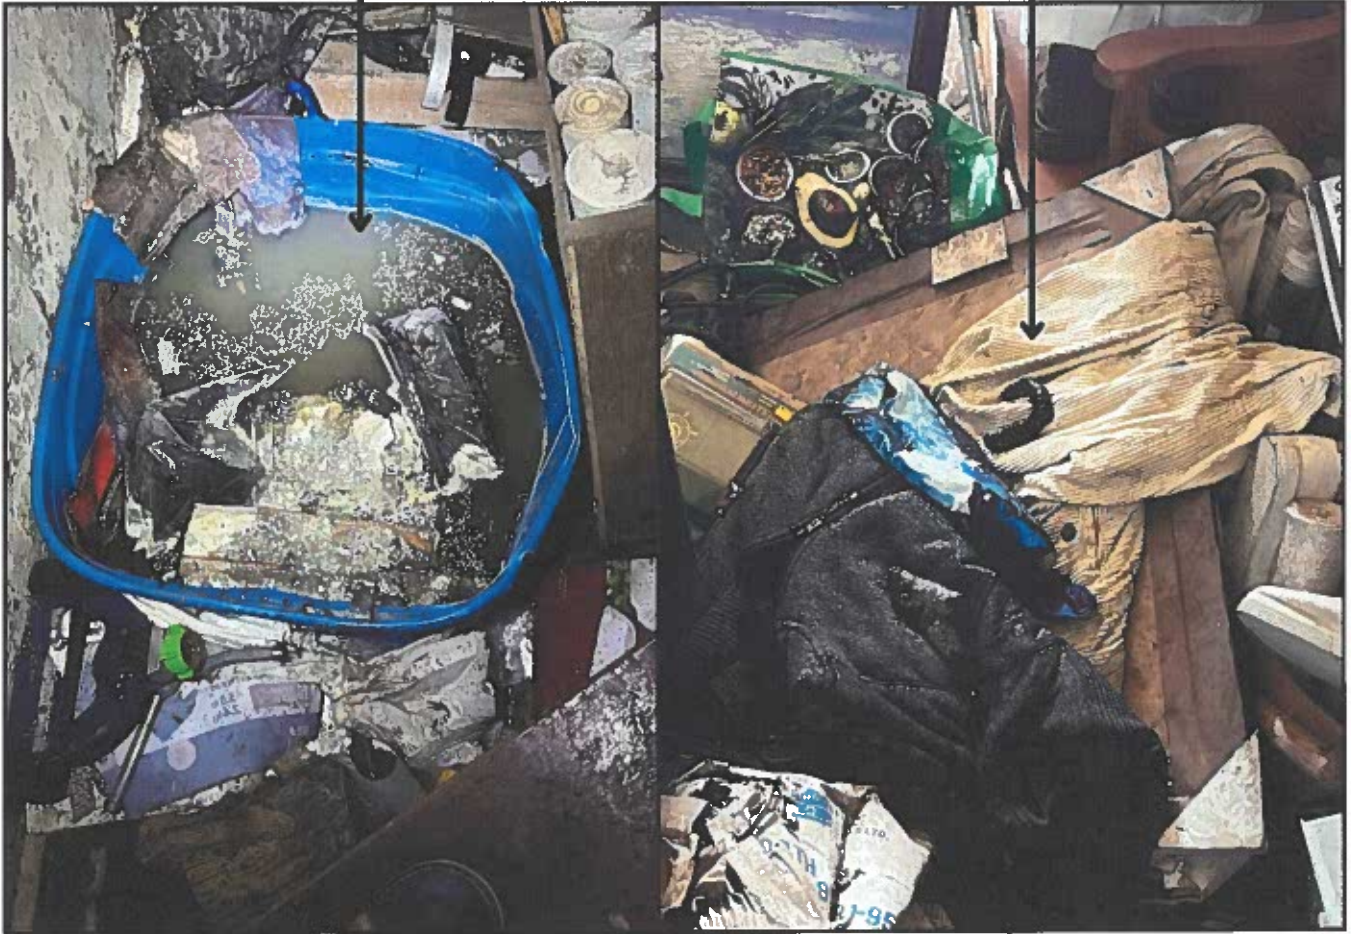
Multiple Bio Hazards

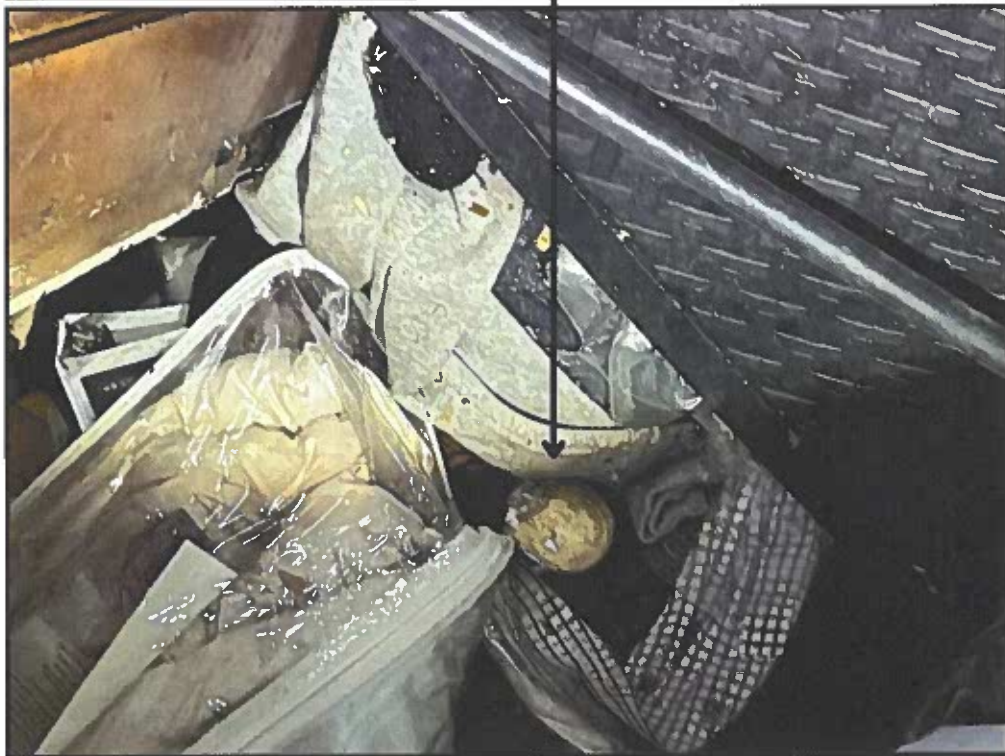
Mold present in various areas throughout the house

Outdated plumbing

Various bio hazards and mushroom growth
