**j.m. giffin engineering inc.**  
**structural consultants**

Re: Building Review, Corner of Church & Prince Arthur St., Amherst, NS/J49-07819

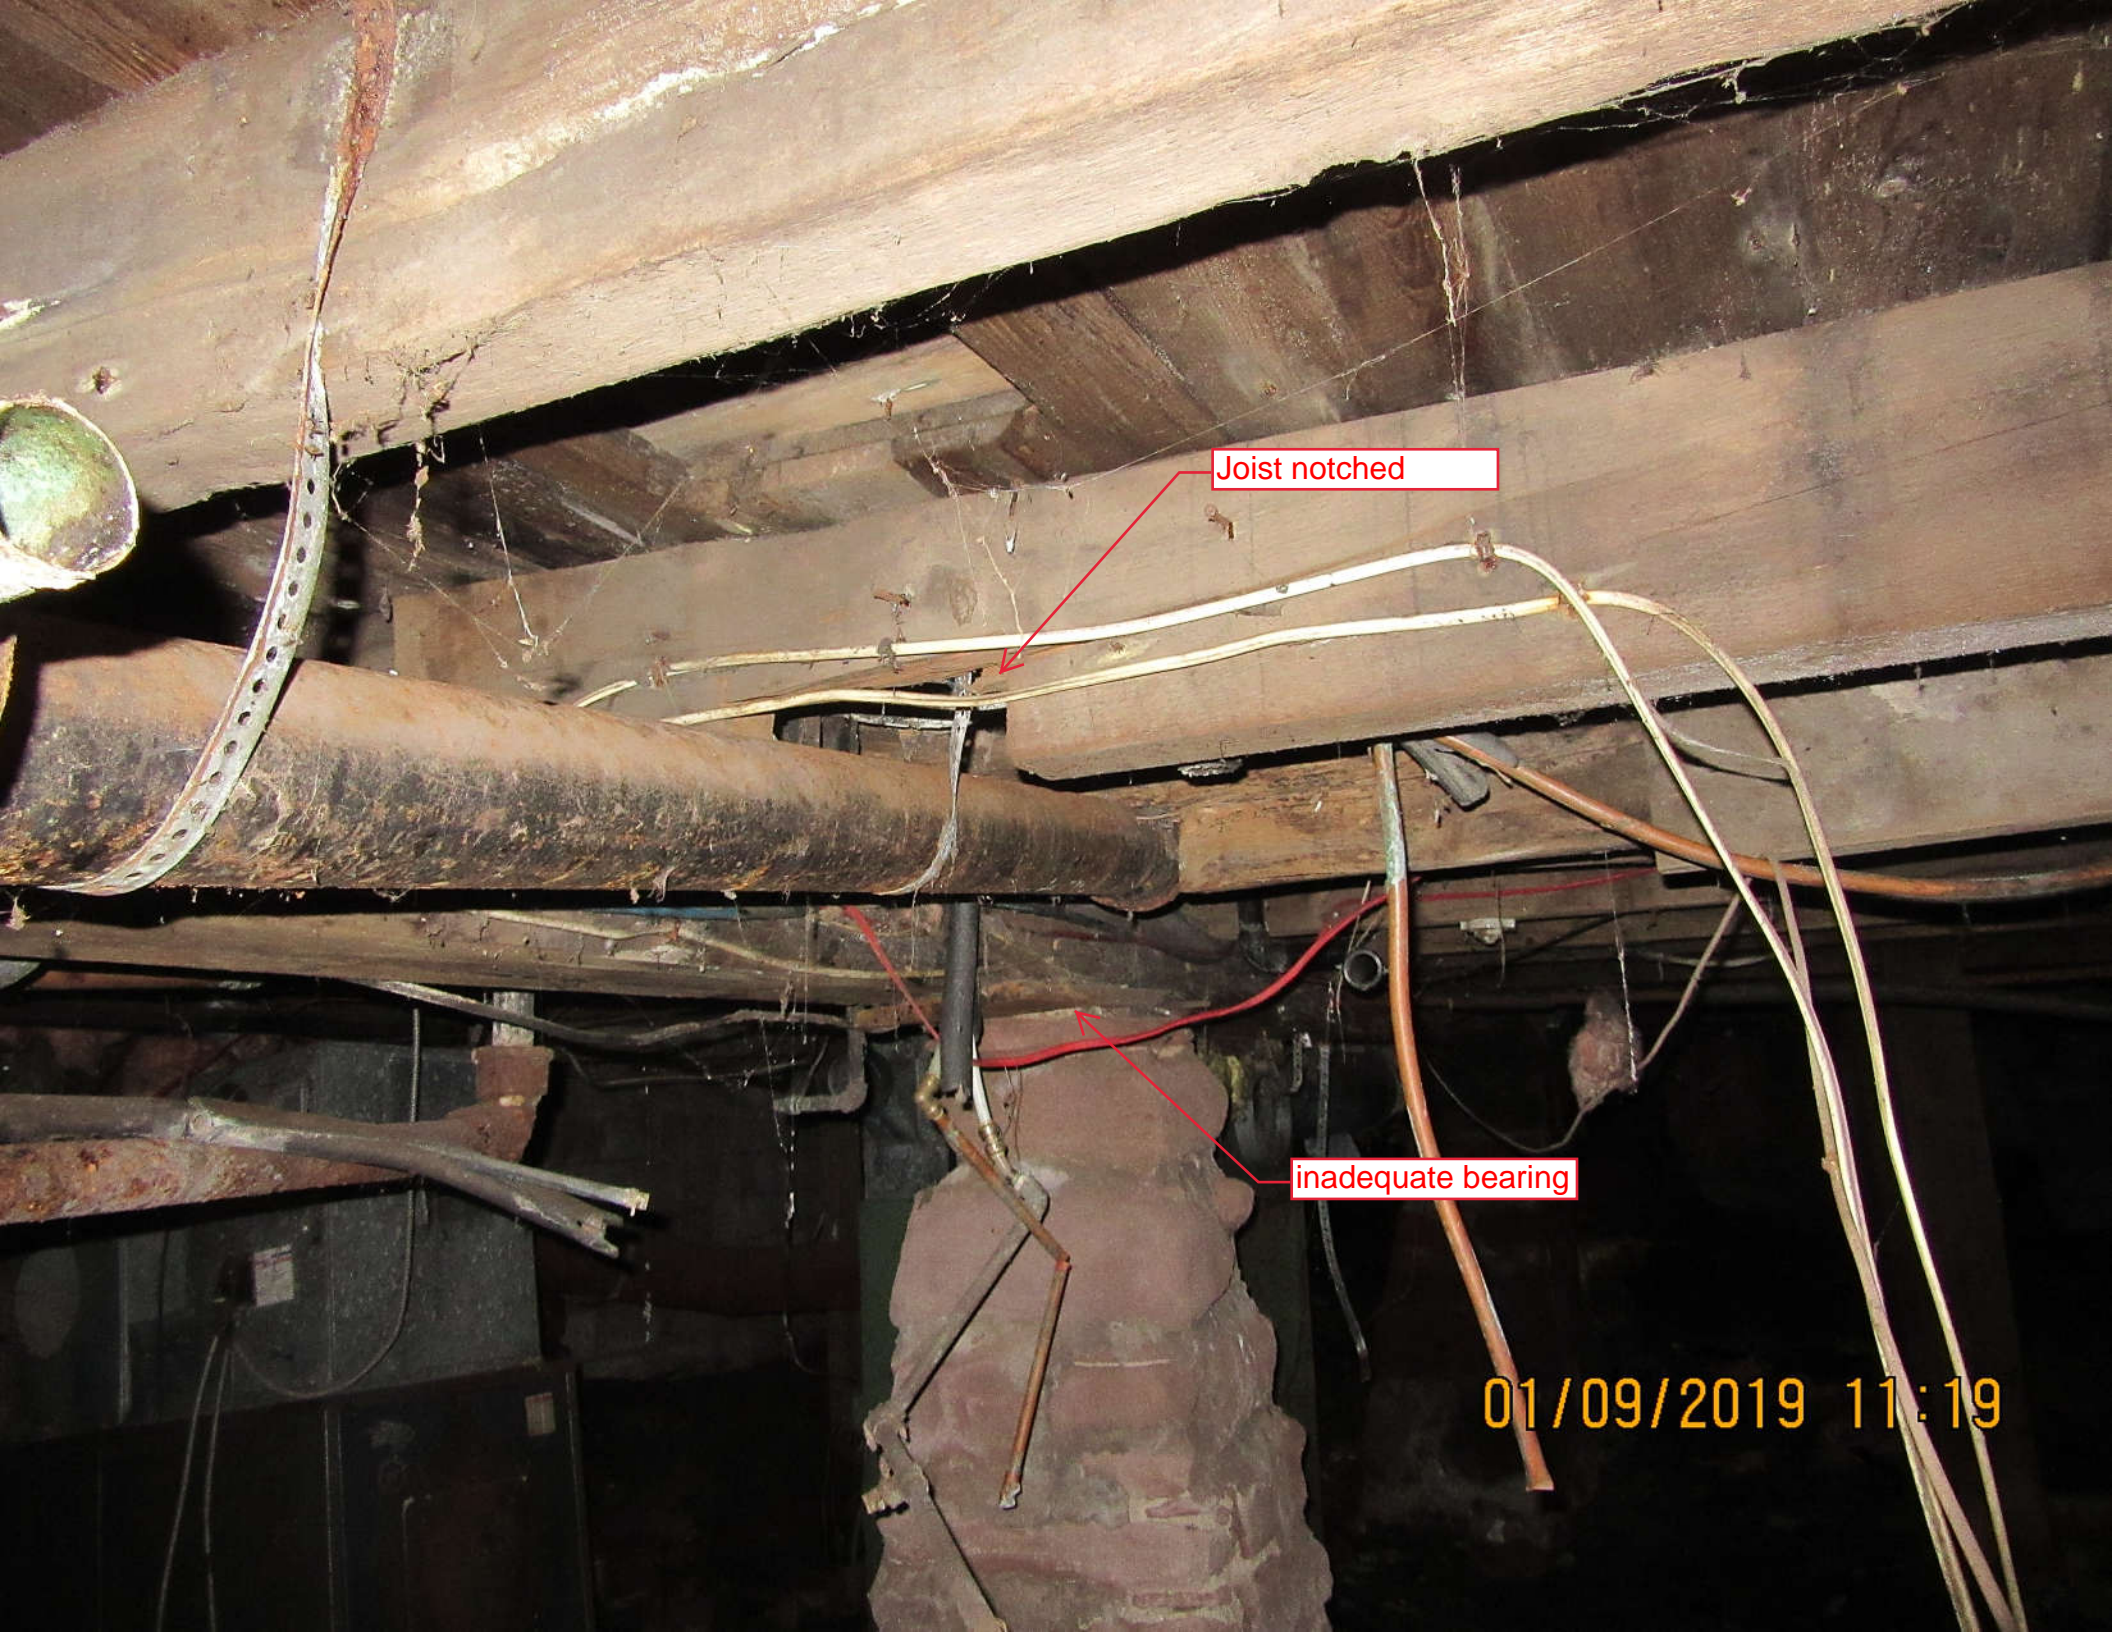
01/09/2019 11:19

Joist cut

Rotted center  
beam

Joist notched

inadequate bearing

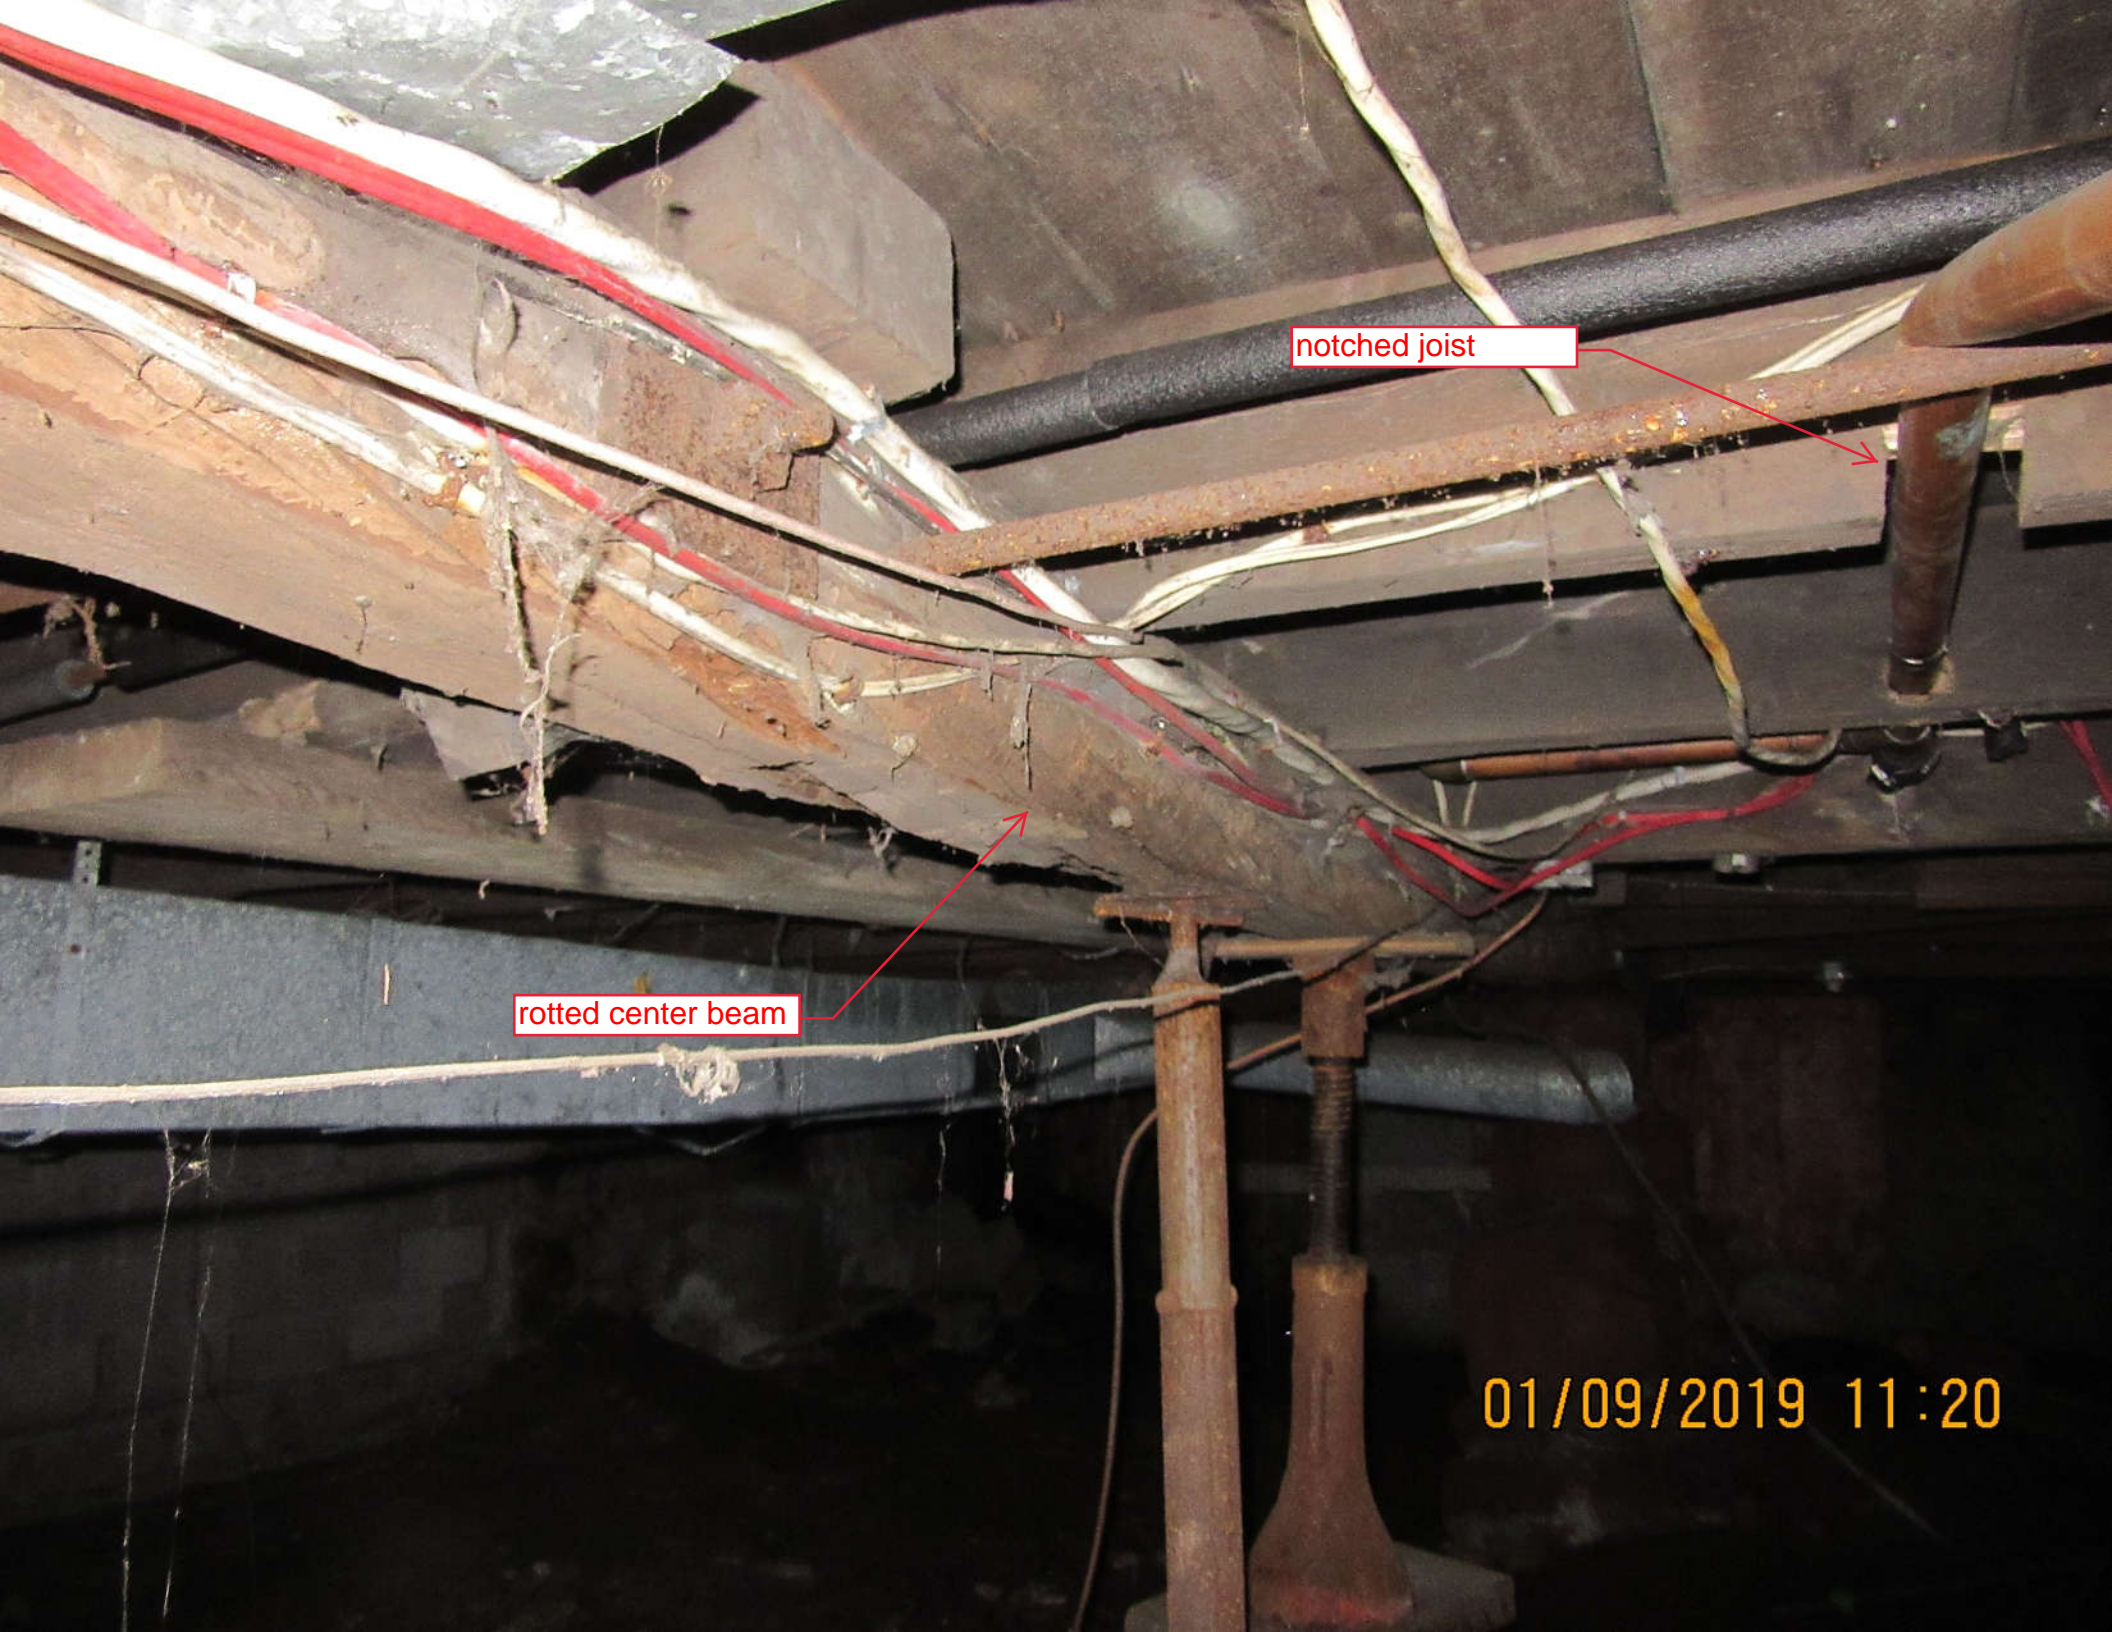
01/09/2019 11:20

sill completely  
deteriorated

end of joist rotted  
and dropped

foundation poor  
condition

Given the extent of the deterioration and deficiencies, complete replacement of the floor system would be required including the wood sills as well as foundation upgrades. With the poor condition of the overall building, it is my opinion, this level of investment would not be justified.

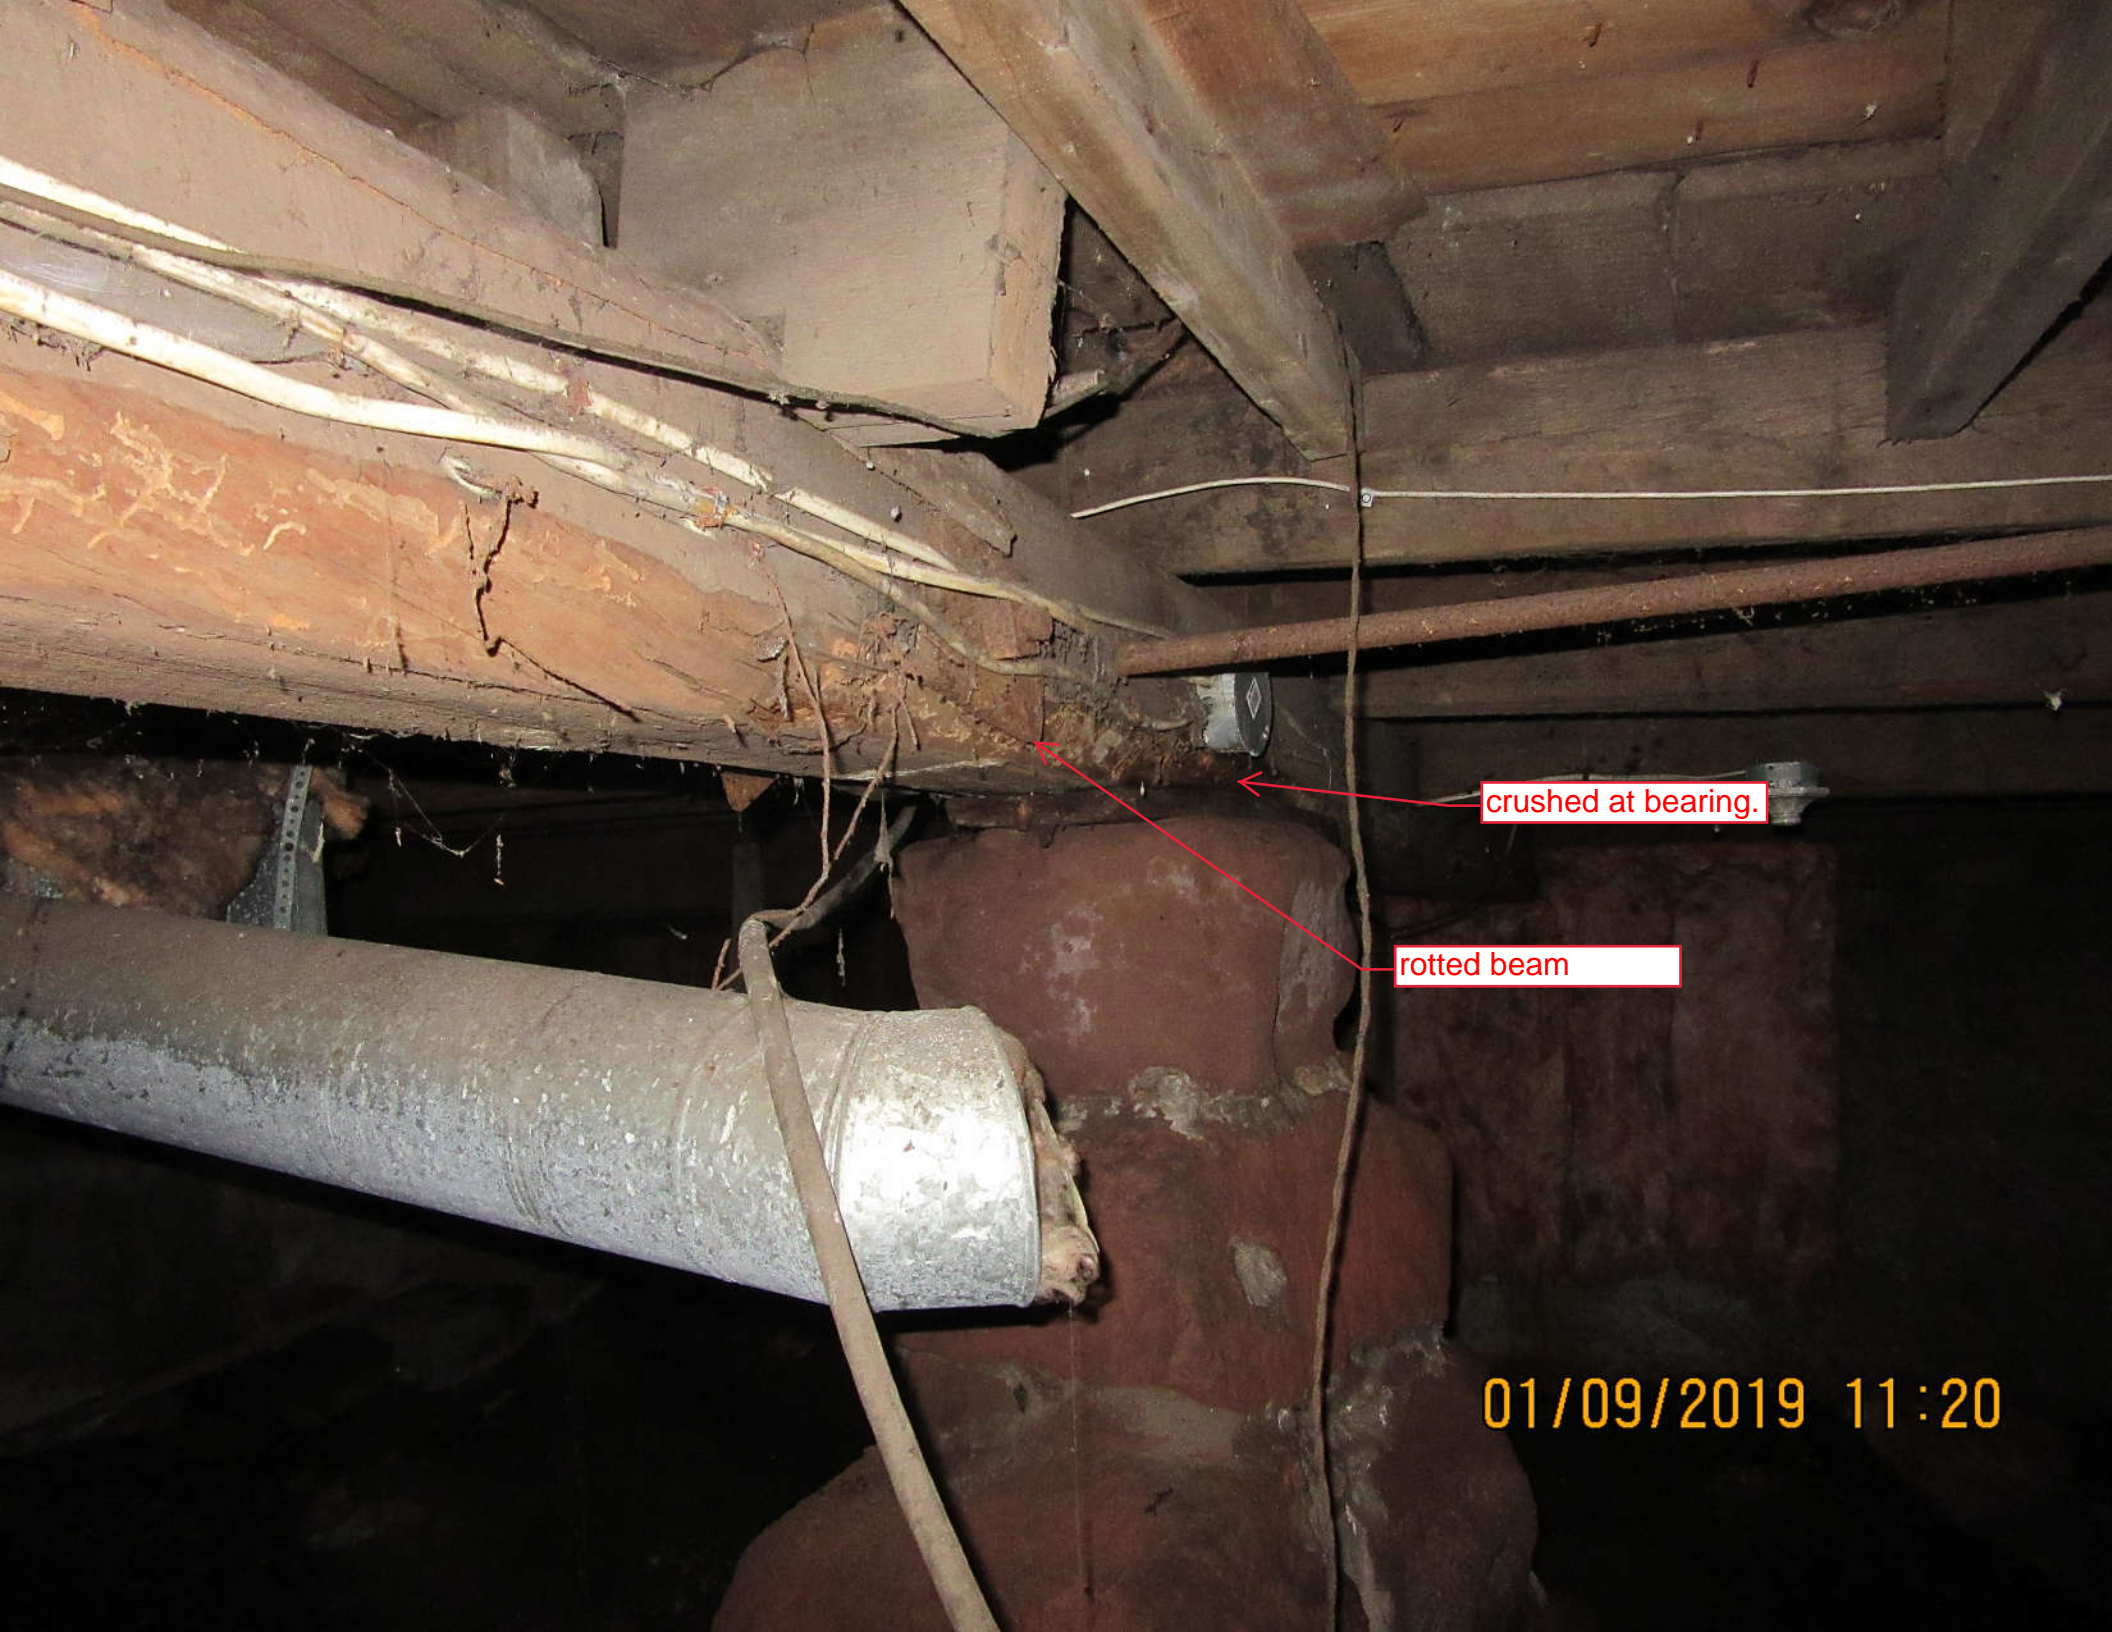
01/09/2019 11:20

notched joist

rotted center beam
