**Town of Amherst
Planning Advisory Committee Meeting**

Subject: Recommendation for Demolition

Re: PID # 25031469, 1 Spring Street, Amherst, NS

RE: Site Inspection – Spring Street, Amherst – PID# 25031469
Pictures attached

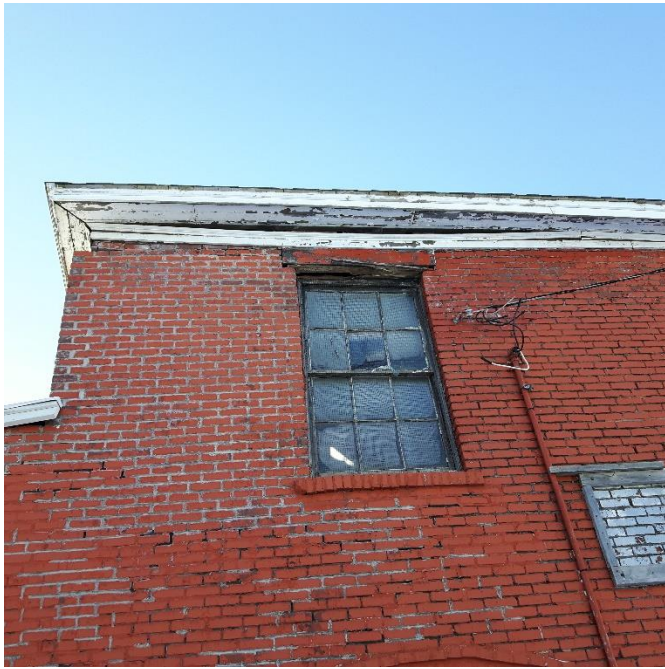
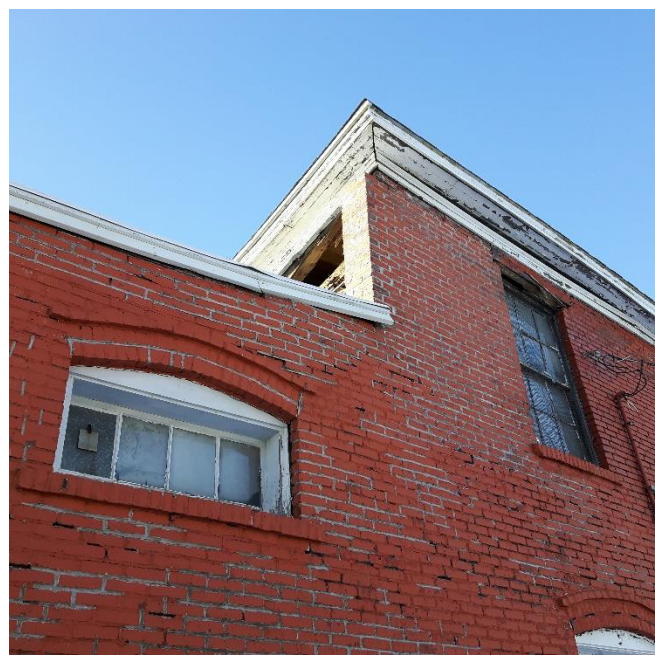
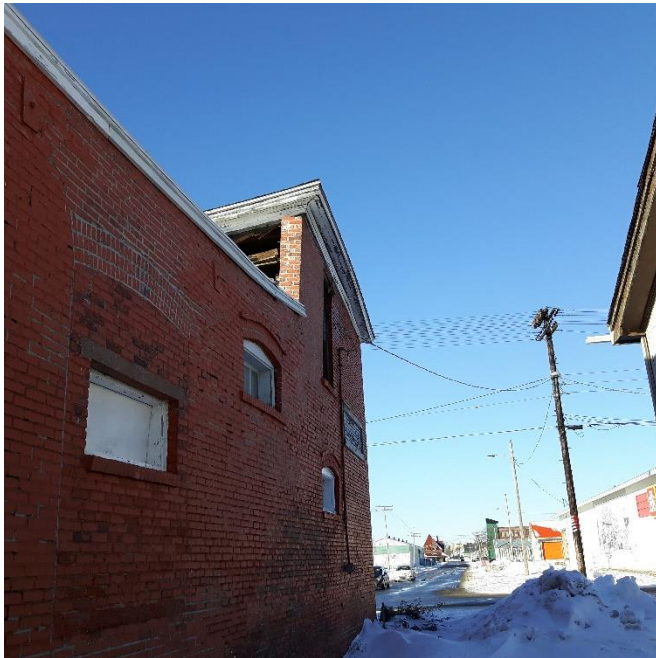
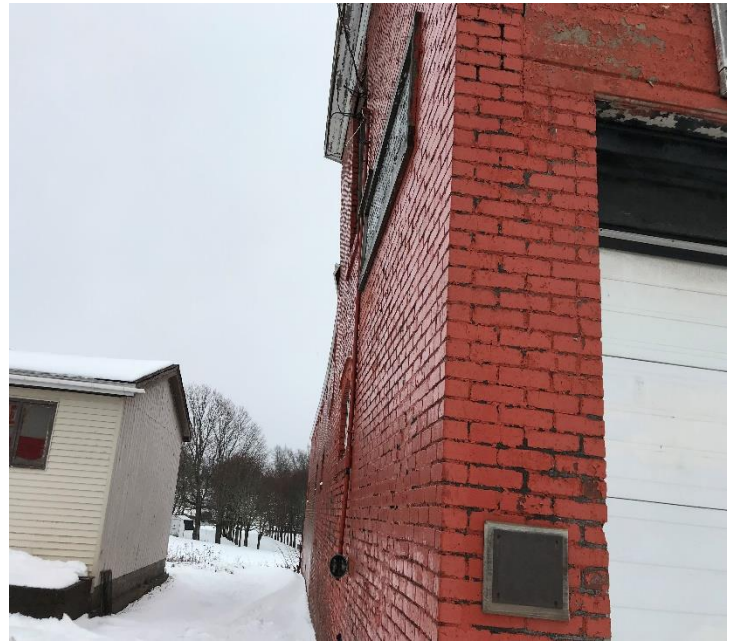
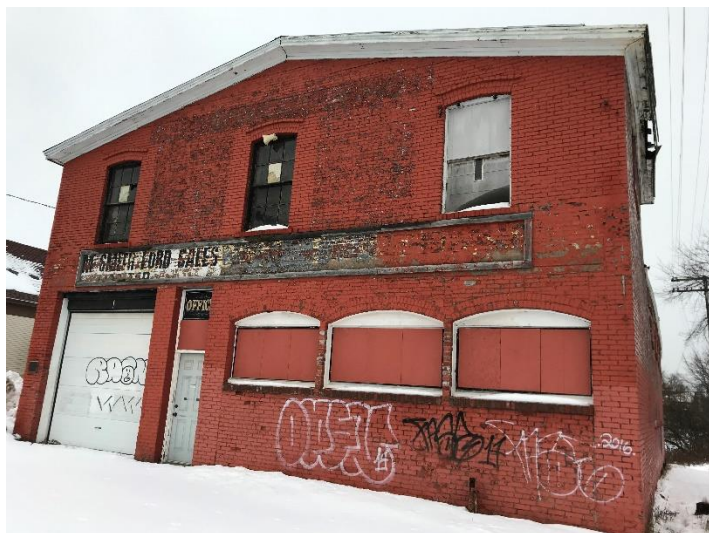
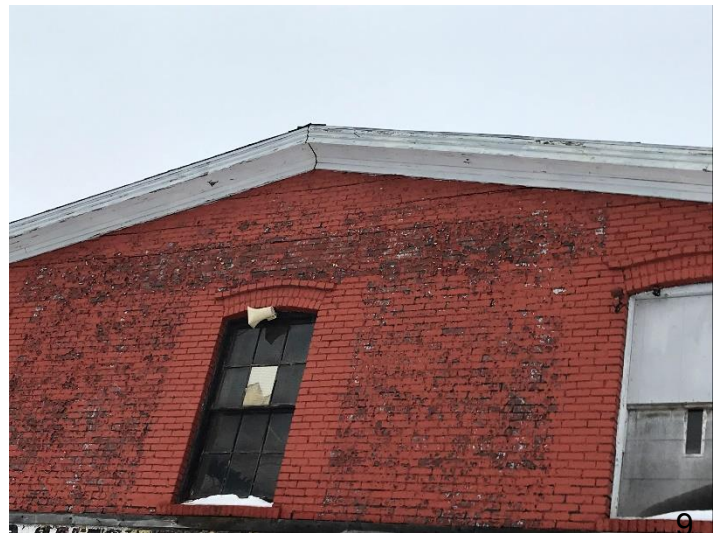
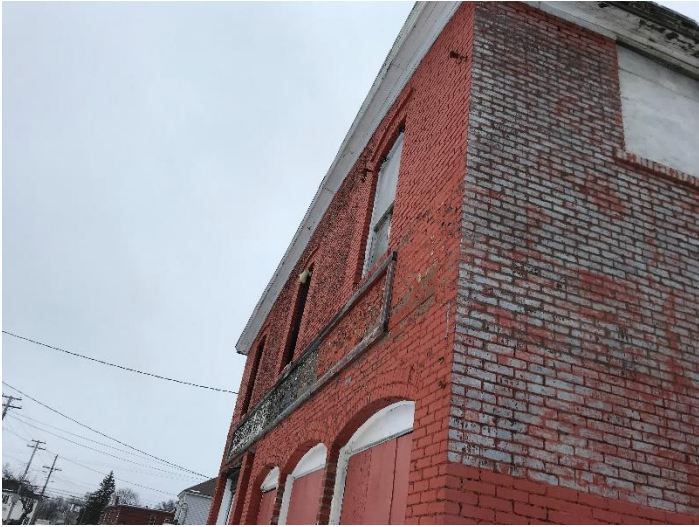
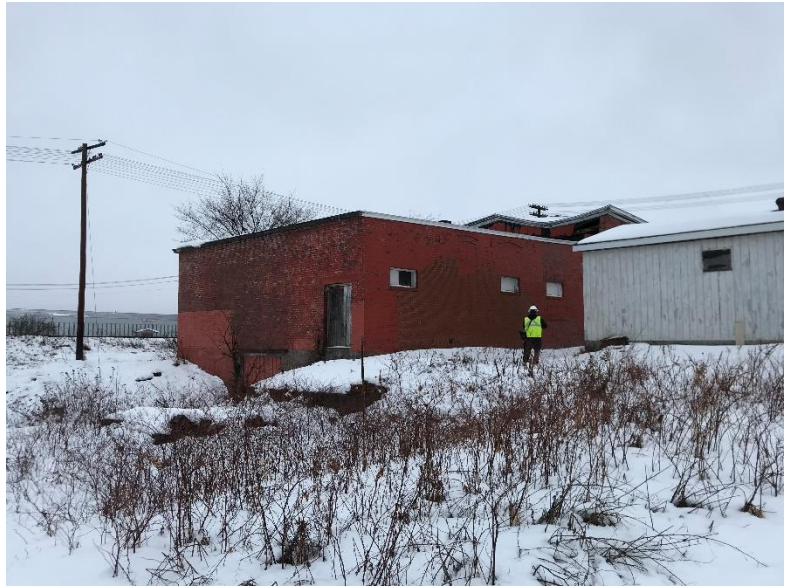
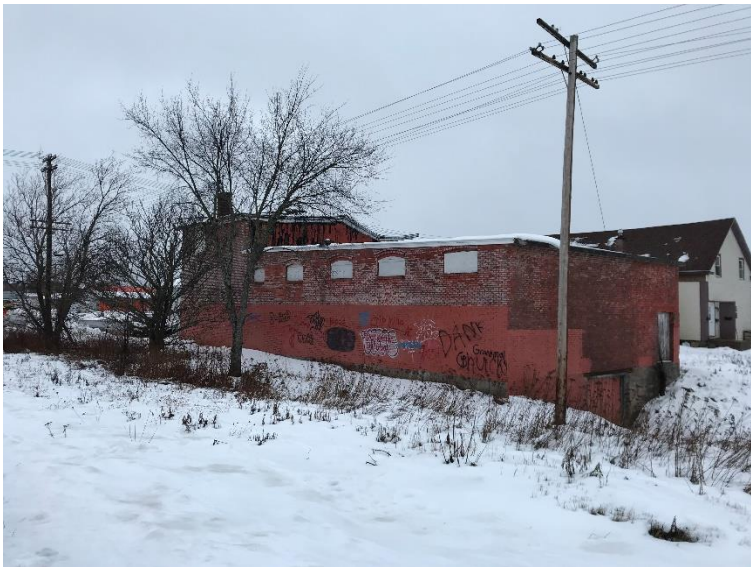
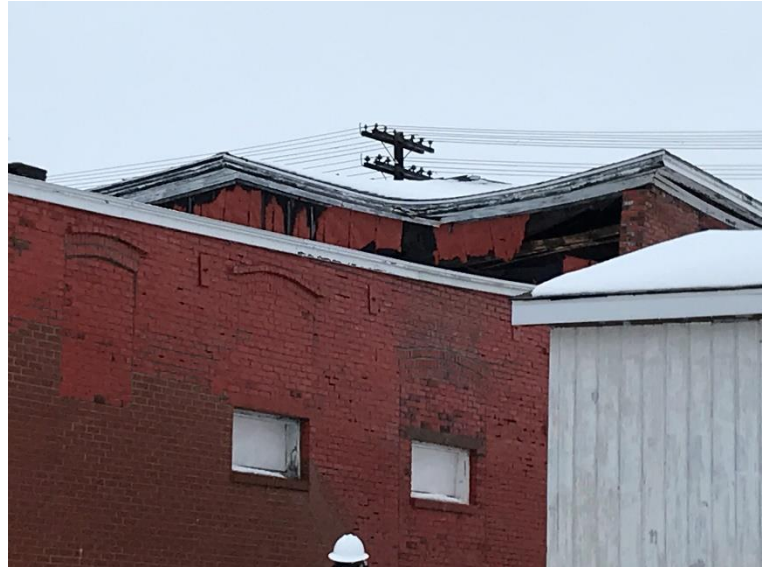
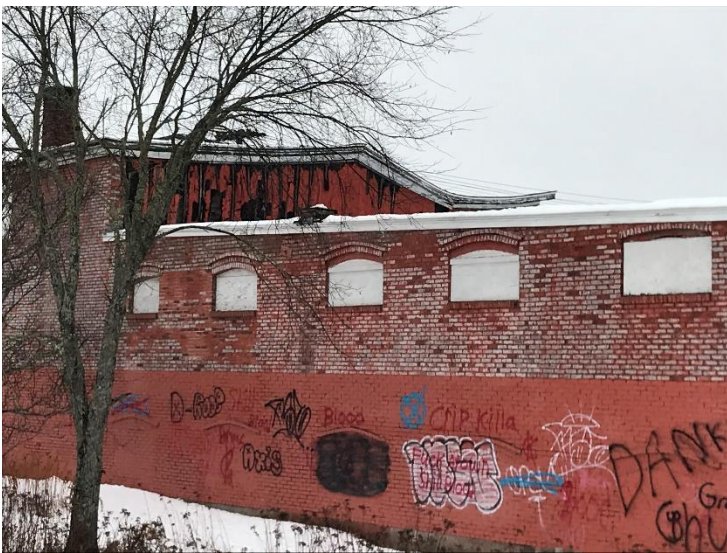
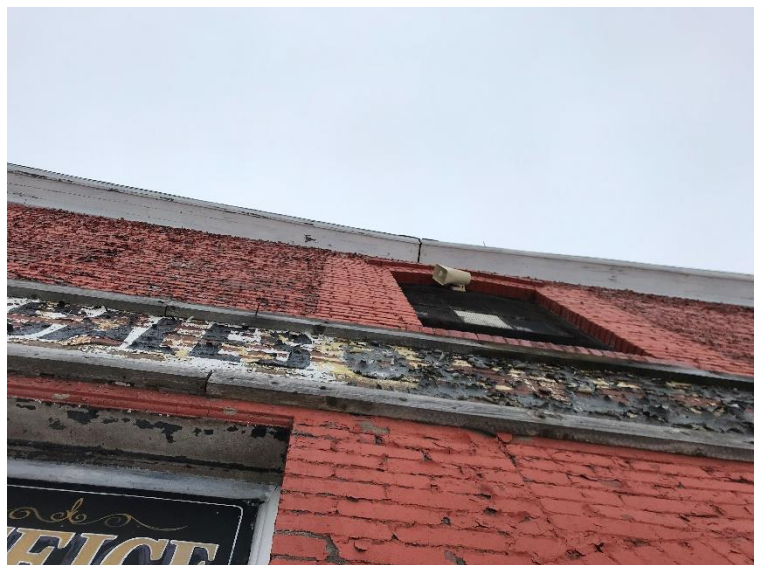
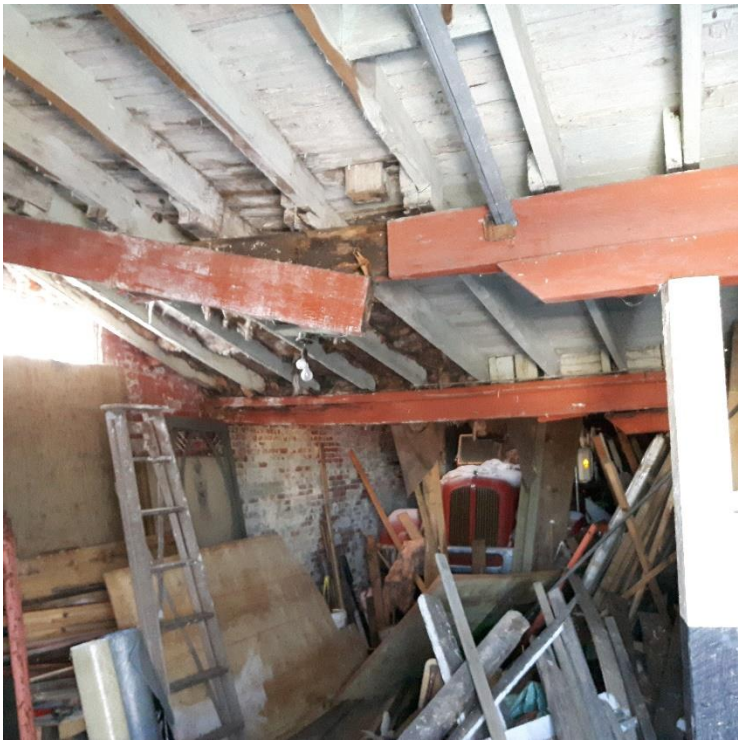
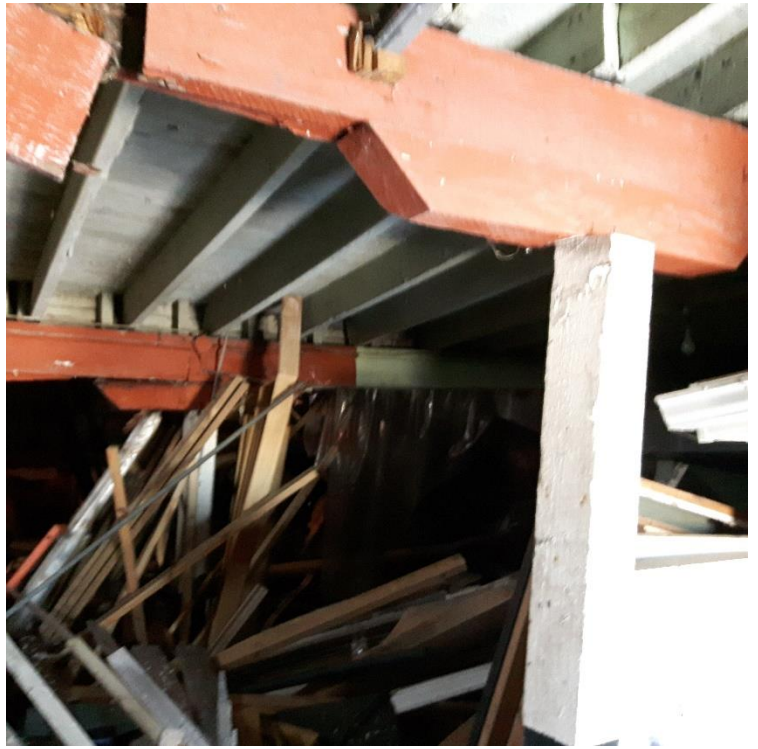
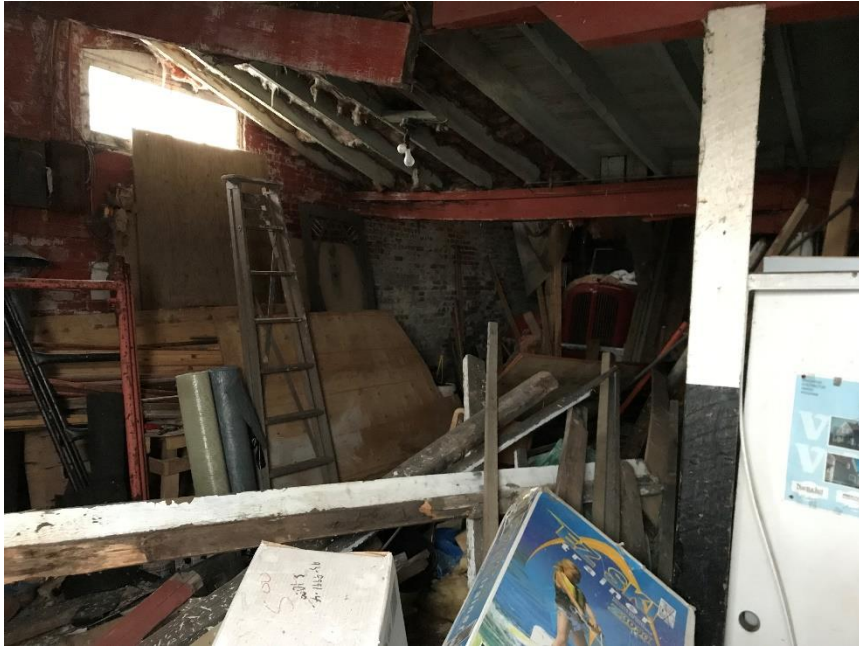
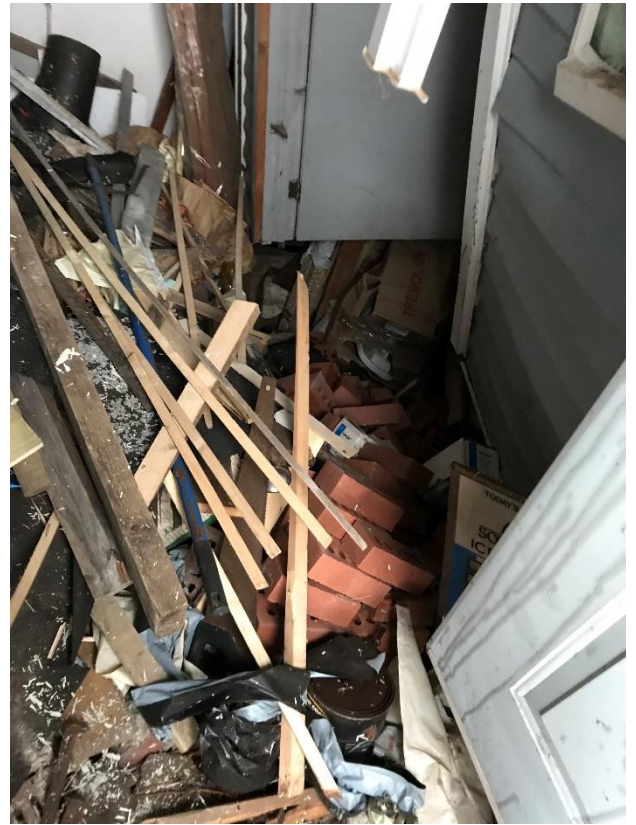
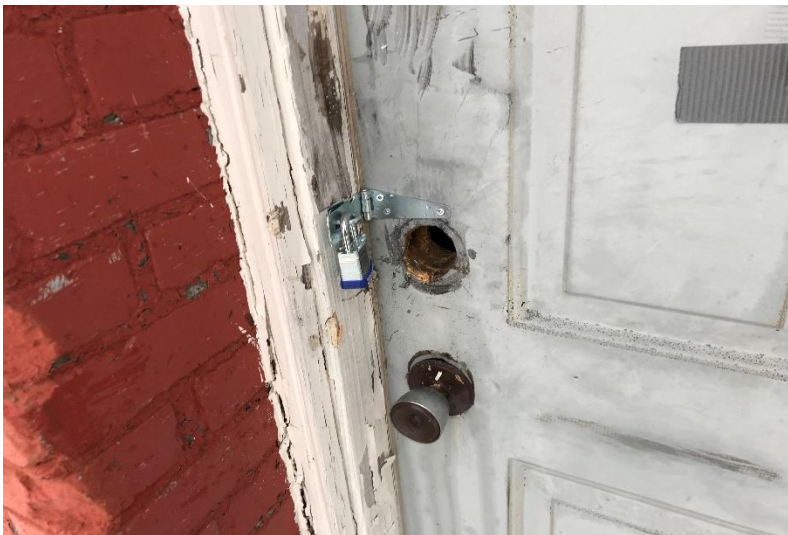
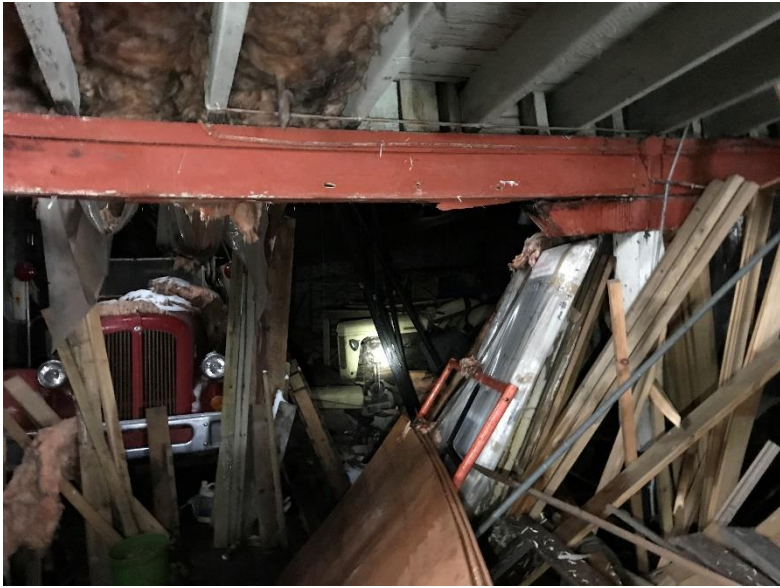
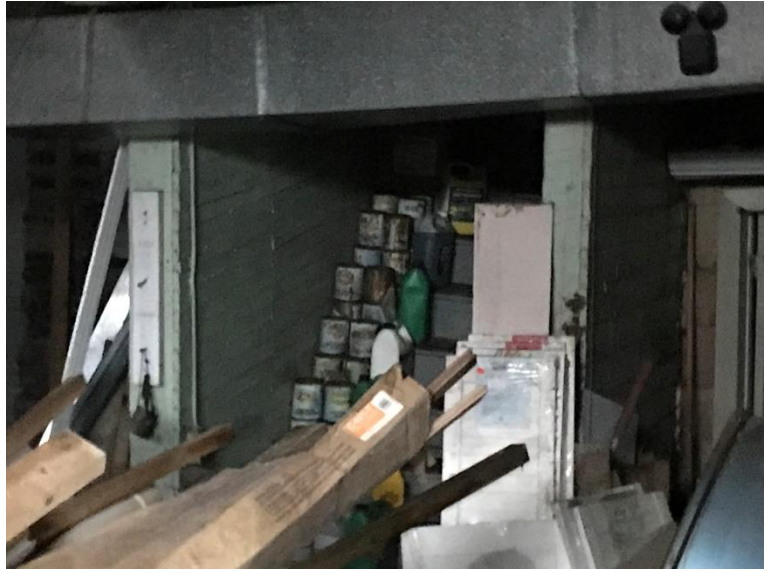
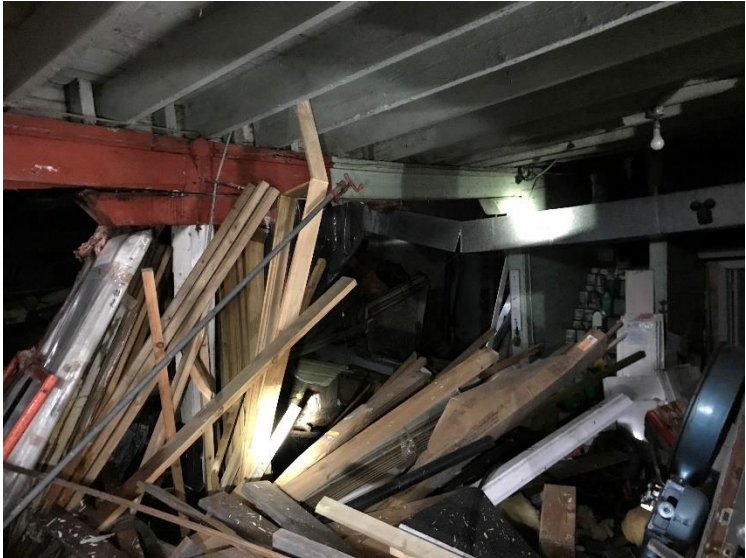
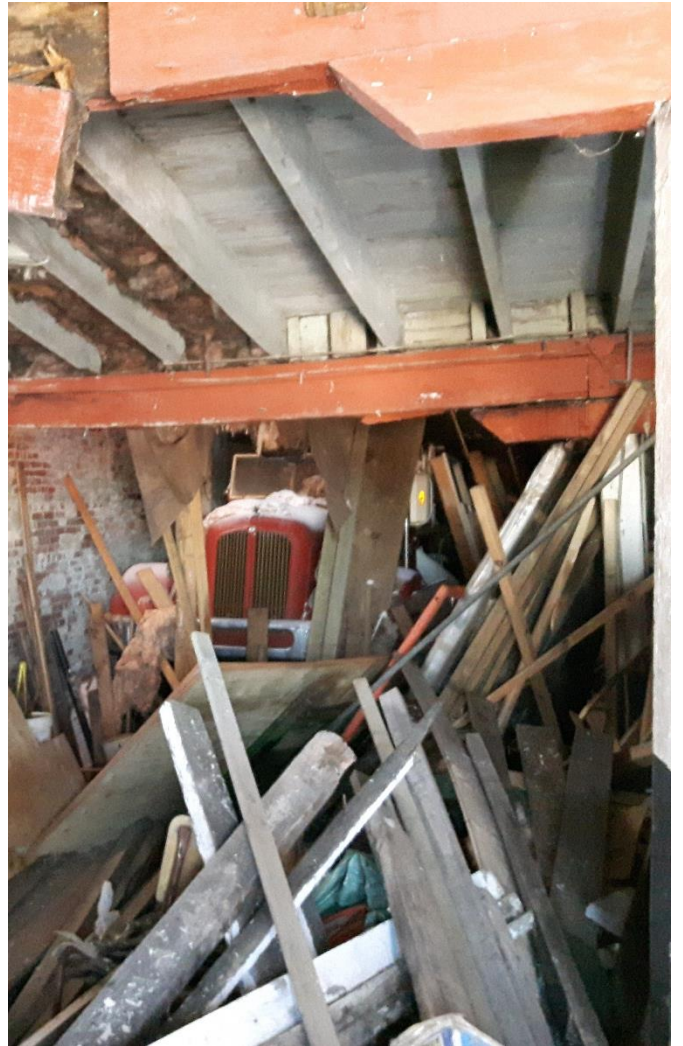
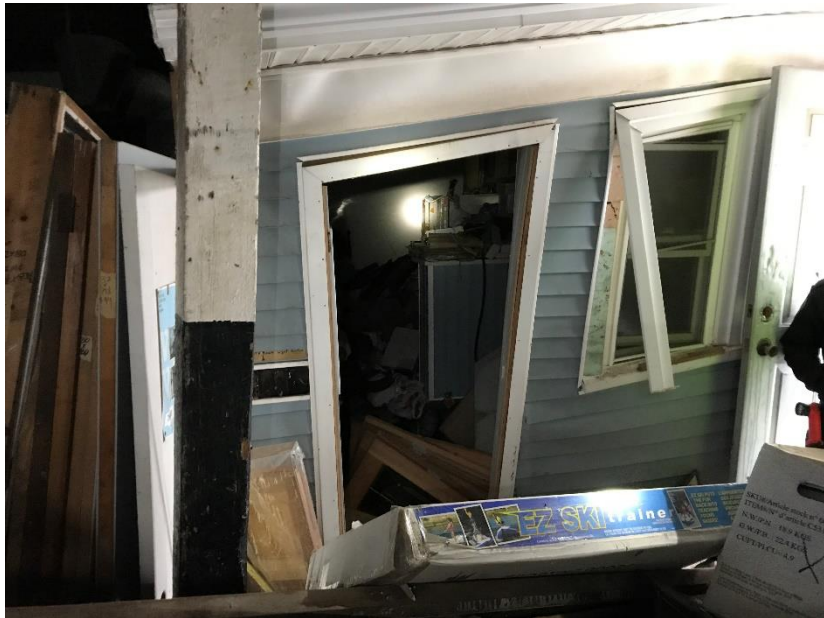
- The entire brick face including previously repaired portions showed signs of mortar failure and cracking.
- The top plate at junction between roof and wall is open in sections, rotted at various points around the perimeter and show structural failure.

- The top wall on the backside of the exterior is collapsed inward and shows signs of continued deterioration.
- Front wall and side show signs of structural failure, leaning and bulging around most of the surface area. Collapse is imminent.

- Side wall on top portion of building left hand side shows, cracking, leaning outward and disconnect from roof structure. Collapse could happen at anytime and should be addressed as soon as possible.

- Interior of building shows near complete structural failure.
- Collapsed floor open to below.
- Roof support beam failed and is broken, support posts out of alignment and failure of roof rafter system.

- Roof is collapsed and open to the elements. Interior of building filled with refuse, debris and materials that inhibit any time safe restoration of interior structure.

It is in the opinion of this inspector that the building structure is in a probable possible state of partial collapse at any time and that the site be secured against possible harm to the public until such a time that it can be safely demolished, at the earliest opportunity. This building is in imminent risk of collapse and threatens the safety of the public.

I am recommending the property at 1 Spring Street be demolished and the foundation be backfilled within 30 days from the date of this committee meeting, with all work to be done by the property owner, including proper disposal of all items within the building. Failure to do so will result in the Town completing the work. All costs incurred by the Town in the demolition and cleanup will be added to the owner's property taxes.
